ControlLogix Controllers, Revision 19

ControlLogix Controllers Catalog Numbers

1756-L61, 1756-L62, 1756-L63, 1756-L64, 1756-L65, 1756-L72, 1756-L73, 1756-L74, 1756-L75

This publication describes enhancements, anomalies (corrected and known), and restrictions for ControlLogix controllers, firmware revisions 19.015, 19.013 and 19.011, and GuardLogix controllers, firmware revisions 19.015 and 19.011.

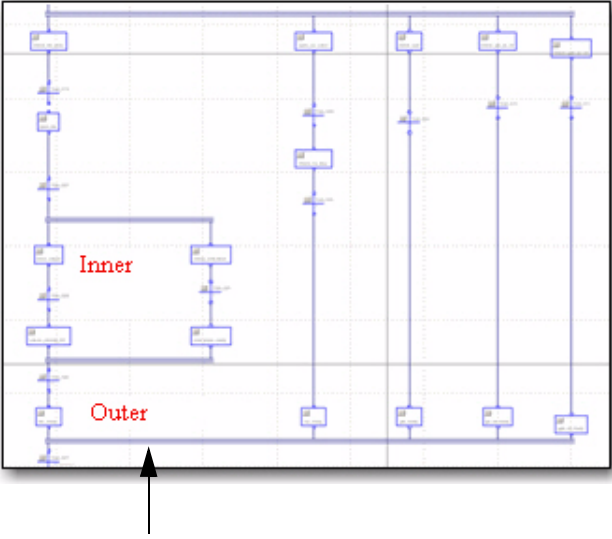
Cat No.	Description
1756-L61, 1756-L62, 1756-L63, 1756-L64, 1756-L65, 1756-L61S, 1756-L62S, 1756-L63S, 1756-L63XT, 1756-L72, 1756-L73, 1756-L74, 1756-L75	<p>An anomaly can occur when you nest simultaneous branches in a Sequential Function Chart (SFC) routine as shown below.</p> <div>

</div> <p>During normal operations, the logic does not step out of a simultaneous branch until all of the incoming legs have reached their bottom-most step. In the example shown, the logic does not step out of the Outer simultaneous branch until the leftmost leg has stepped out of the Inner simultaneous branch. The first time through the SFC routine, the application works as expected. On subsequent scans, however, the chart steps out of the Outer simultaneous branch even though the left leg has not reached the Inner simultaneous branch yet.</p> <p>This behavior occurs because the information in the bottom step, that is, the step next to the word Outer, remains from the previous scan. This stale information incorrectly causes the transition to move on as if the left leg is at the bottom step when it actually is not.</p> <p>To work around this anomaly, confirm all of the incoming legs have reached their bottom steps in the transition. You can check the .x bits to make sure the bottom-most step of each converging leg is active before allowing the chart to advance. This check can be added to the transition logic already present.</p> <p>For example, the steps in the following expression are the bottom steps (see graphic above) of the incoming legs. Each step has a timer. The transition does not move on until all of the step timers have reached their preset value.</p> <p>The expression can be modified to be sure those steps are truly active. This is the original expression:</p> <pre>// Unit is ready to Transition Step1_ready.dn and Step2_ready.dn and Step3_ready.dn and Step4_ready.dn and Step5_ready.dn</pre> <p>This is the modified expression to workaround this anomaly.</p> <pre>// Unit is ready to Transition Step1_ready.x and Step2_ready.x and Step3_ready.x and Step4_ready.x and Step5_ready.x and Step1_ready.dn and Step2_ready.dn and Step3_ready.dn and Step4_ready.dn and Step5_ready.dn</pre> <p>IMPORTANT: The x bit is cleared when the chart transitions out of a step.</p> <p>Adding this check to the condition forces the engine to wait until all of those steps are genuinely active before advancing out of the simultaneous branch.</p> <p>Lgx00118189, Lgx00116506</p>
