1769 CompactLogix Packaged Controllers, Revision 17

Catalog Numbers 1769-L23E-QB1B, 1769-L23E-QBFC1B, 1769-L23-QBFC1B

About Publication 1769-RN012

Publication 1769-RN012F-EN-E - February 2013

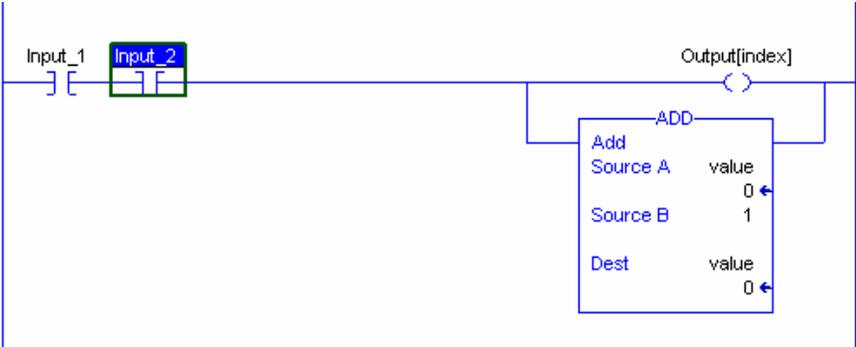
<p>Fault handlers can be defined at the controller and program scope levels. These fault handlers are typically used to handle major recoverable faults that can occur during runtime execution of an application due to programming errors. A typical example of this would be handling indirect addressing that has gone out of range; MyTag[index], where index is larger than the size of the array.</p> <p>Faults can also be handled by the controller during pre-scan of the controller program on the transition to Run mode. Again, for example, the handling of indirect addressing that has gone out of range.</p> <p>There is an anomaly when these methods attempt to handle a fault.</p> <p>These are the possible ways the anomaly can manifest itself:</p> <ul style="list-style-type: none"> • The controller will experience a major non-recoverable fault. I/O goes to their configured safe state, and the user application is cleared from memory. At this point, a Code 1 Type 60 or 61 major recoverable fault will be logged in the controller. This requires you to redownload the application. • Tag data corruption. • Online saving or uploading failures. • Anomalous program execution. <p>For example, if a rung is being scanned false and there is an instruction that has false execution, the fault handler executes so the remainder of the rung will scan true. In the example below, the OTE instruction has an index out of range. After returning from the fault handler, the ADD instruction will execute, even though the rung input conditions are false.</p>
