Using 1771-IBN and 1771-IVN Modules in a PLC-5 Extended Local System

Release Notes

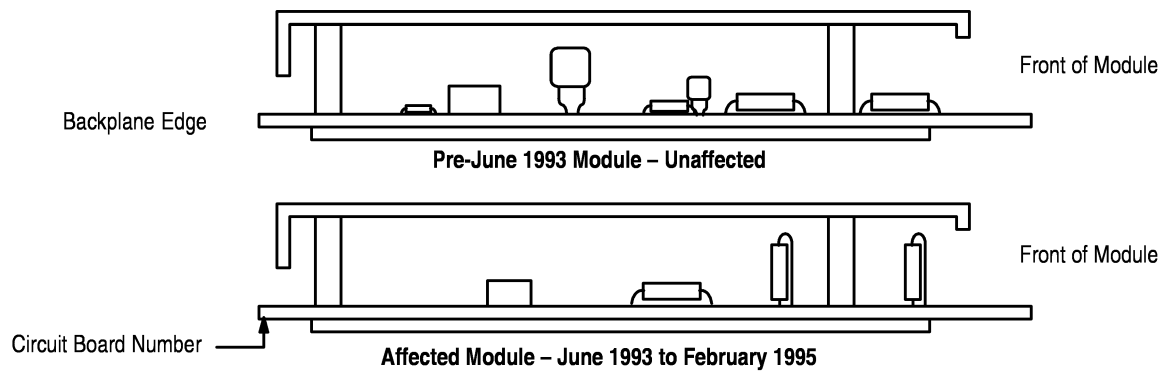
Affected modules are identified by part numbers on the backplane edge of the printed circuit board (see table), or component layout (see illustration).

² These modules do not have a 961□□□□□ number on the backplane edge of the circuit board. Refer to the illustration.

You can identify pre-June 1993 modules by viewing the module from the bottom.

We strongly recommend immediate replacement or repair of any affected modules. For details, contact your local A-B district office.
