# **ControlLogix Controllers, Revision 18**

## **ControlLogix Controllers Catalog Numbers**

This publication describes enhancements, anomalies (known and corrected), and restrictions for ControlLogix and GuardLogix controllers, revision 18.

Publication 1756-RN018A-EN-P - February 2010

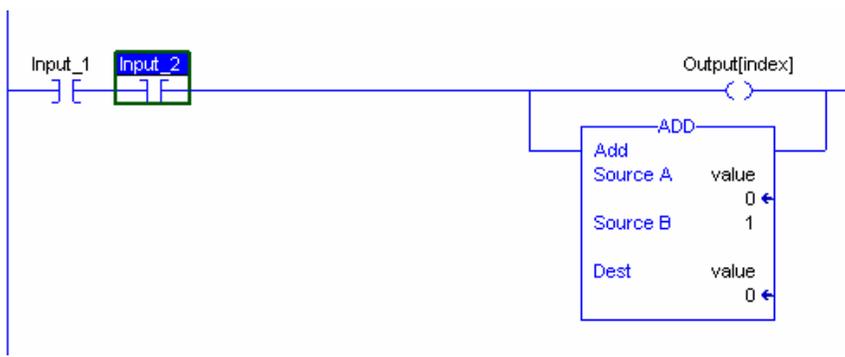
Catalog No.	Description
1756-L61, 1756-L62, 1756-L63, 1756-L64, 1756-L65 1756-L61S, 1756-L62S, 1756-L63S, 1756-L63XT	<p>Fault handlers can be defined at the controller and program scope levels. These fault handlers are typically used to handle major recoverable faults that can occur during runtime execution of an application due to programming errors. A typical example of this would be handling indirect addressing that has gone out of range; MyTag[index], where index is larger than the size of the array.</p> <p>Faults can also be handled by the controller during pre-scan of the controller program on the transition to Run mode. Again, for example, the handling of indirect addressing that has gone out of range.</p> <p>There is an anomaly when these methods attempt to handle a fault.</p> <p>These are the possible ways the anomaly can manifest itself:</p> <ul style="list-style-type: none"><li>• The controller will experience a major non-recoverable fault. I/O goes to their configured safe state, and the user application is cleared from memory. At this point, a Code 1 Type 60 or 61 major recoverable fault will be logged in the controller. This requires you to redownload the application.</li><li>• Tag data corruption.</li><li>• Online saving or uploading failures.</li><li>• Anomalous program execution.</li></ul> <p>For example, if a rung is being scanned false and there is an instruction that has false execution, the fault handler executes so the remainder of the rung will scan true. In the example below, the OTE instruction has an index out of range. After returning from the fault handler, the ADD instruction will execute, even though the rung input conditions are false.</p>
