ControlLogix® Redundancy System Revision 11

Cat. No. 1756-L55, -L55M12, -L55M13, -L55M14, -L55M16, -L55M22, -L55M23, -L55M24, -CNB/D, -CNBR/D, -ENBT/A, 1757-SRM/A, -SRM/B

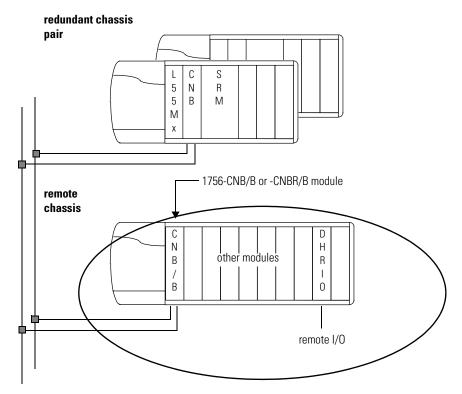
Communication Loss When Bridging Through a 1756-CNB/B or -CNBR/B Module The following combination of modules in a remote chassis could cause a temporary communication loss with the chassis:

- 1756-CNB/B or -CNBR/B module
- 1756-DHRIO module that is connected to a remote I/O network.

On the first switchover after you download a project to the controller, you may temporarily lose communications with these devices.

The loss of communication occurs on the first switchover after you download the project to the redundant controller.

- You lose communication with the remote chassis and any devices to which you were bridging via the chassis, such as the remote I/O modules.
- During the communication loss, the I/O modules go to their configured state for a communication fault.
- The communication loss is temporary. Communications restore themselves.

To prevent this situation, use 1756-CNB/D or -CNBR/D modules.
