# ControlLogix Controllers Revision 13

Cat. No. 1756-L1, -L1M1, -L1M2, -L1M3, -L55, -L55M12, -L55M13, -L55M14, -L55M16, -L55M22, -L55M23, -L55M24, -L61, -L62, -L63

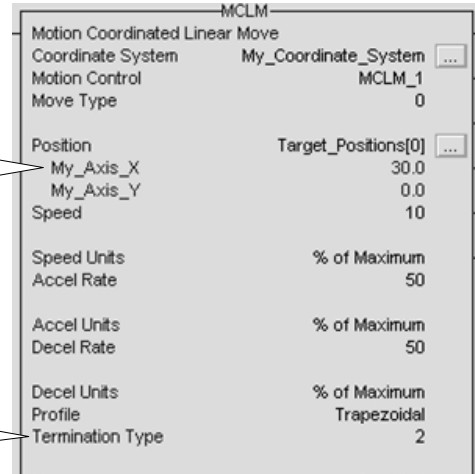
MCLM Instruction Sometimes Caused an Extra Revolution When an Axis Was Near Its Unwind Position

Sometimes a Motion Coordinated Linear Move (MCLM) instruction moved an axis an extra revolution under these conditions:

The axis was rotary. The move was blending with another MCLM instruction across the unwind position.

Termination Type was 2 or 3.

This happened because of internal round-off in the floating point calculations.

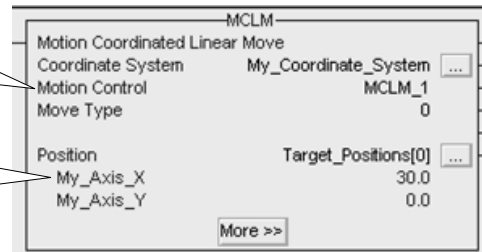
MCLM Instruction Moved an Axis That Was Already at the Target Position

A Motion Coordinated Linear Move (MCLM) instruction moved an axis a full revolution under these conditions:

The Move Type was absolute.

An axis was rotary and it was already at the target position.

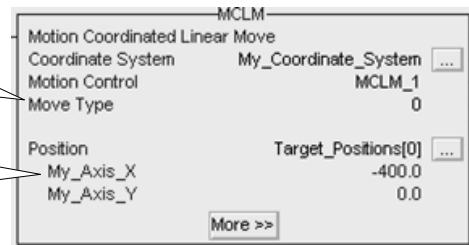
MCLM Instruction Did Not Error with a Target Position Less Than -360°

A Motion Coordinated Linear Move (MCLM) instruction did not error under these conditions:

The Move Type was absolute.

An axis was rotary and its target position was less than -360°

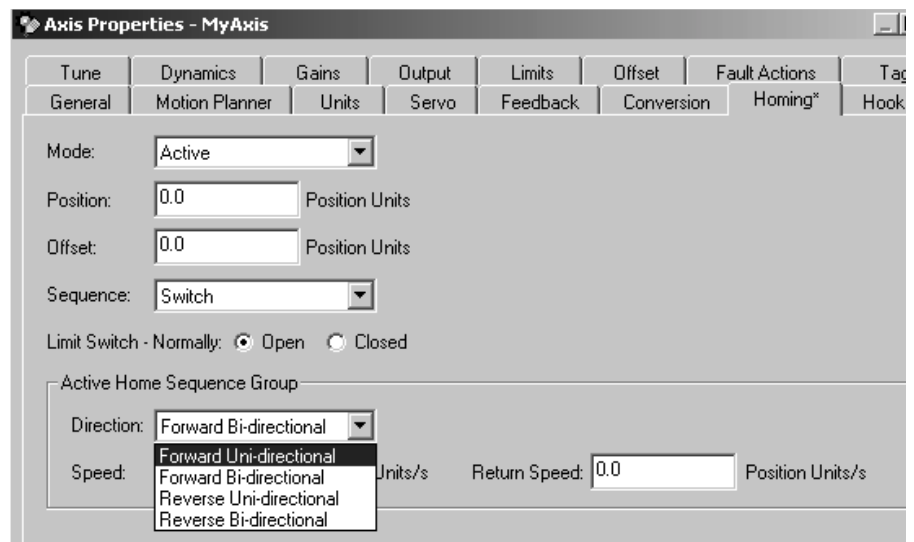
Uni-Directional Homing Failed to Complete

A Motion Axis Home (MAH) instruction sometime failed to complete (IP bit remained on) under the following axis configuration:

- Return Speed = 0
- uni-directional homing (forward or reverse)
