ControlLogix® Redundancy System Revision 8

Cat. No. 1756-CNB/D, -CNBR/D, -L55, -L55M13, -L55M14,
-L55M16, -L55M23, -L55M24, 1757-SRM/A, -SRM/B

Introduction

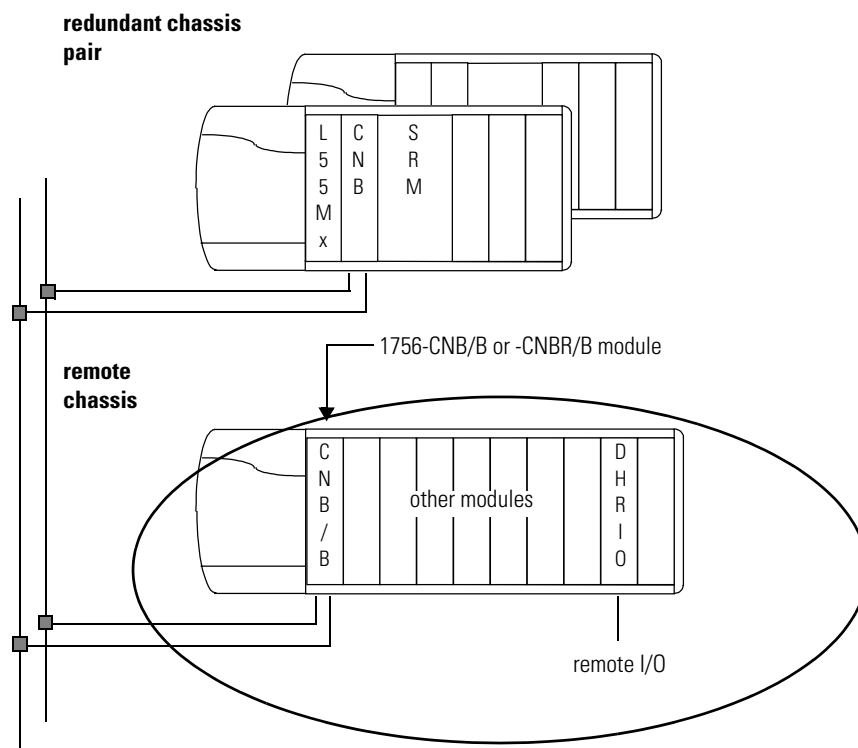
Communication Loss When Bridging Through a 1756-CNB/B or -CNBR/B Module

The following combination of modules in a remote chassis could cause a temporarily communication loss with the chassis:

- 1756-CNB/B or -CNBR/B module
- 1756-DHRIO module that is connected to a remote I/O network.

On the first switchover after you download a project to the controller, you may temporarily lose communications with these devices.

The loss of communication occurs on the first switchover after you download the project to the redundant controller.

- You lose communication with the remote chassis and any devices to which you were bridging via the chassis, such as the remote I/O modules.
- During the communication loss, the I/O modules go to their configured state for a communication fault.
- The communication loss is temporary. Communications restore themselves.

To prevent this situation, use 1756-CNB/D or -CNBR/D modules.

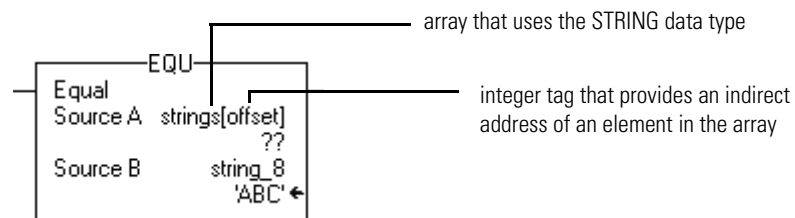
Indirect Addressing of an ASCII String You *cannot* download a project that uses an indirect address (tag in the subscript of an array) to a string data type, as follows:

For example, the following combinations of tags and instruction would prevent a project from downloading:
