ControlLogix Controllers, Revision 18

ControlLogix Controllers Catalog Numbers 1756-L73, 1756-L75

Publication 1756-RN677A-EN-P - July 2010

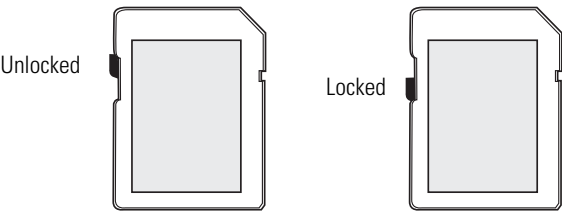
Figure 1 - SD Card - Unlocked and Locked

If your SD card is	Then
Unlocked	You can successfully update the firmware to the intended revision.
Locked and the Load Image option is set to On Power Up	You should unlock the SD card before beginning the update. If the card is locked when you attempt to update the firmware, the update fails and the controller reverts to the firmware revision already stored on the SD card.
