CompactLogix Controllers, Revision 16

Catalog Numbers 1769-L31, 1769-L32C, 1769-L32E, 1769-L35CR, 1769-L35E

These release notes, 1769-RN016F, are specific to firmware revision 16.023 for all CompactLogix controllers.

Publication 1769-RN016F-EN-E - February 2013

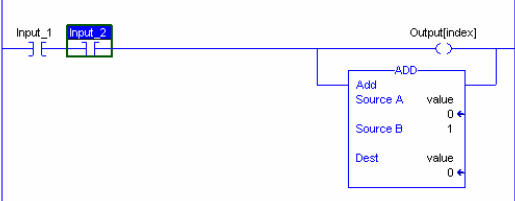
<p>Fault handlers can be defined at the controller and program scope levels.</p>	<p>These fault handlers are typically used to handle major recoverable faults that can occur during runtime execution of an application due to programming errors. A typical example of this would be handling indirect addressing that has gone out of range; MyTag[index], where index is larger than the size of the array.</p> <p>Faults can also be handled by the controller during pre-scan of the controller program on the transition to Run mode. Again, for example, the handling of indirect addressing that has gone out of range.</p> <p>There is an anomaly when these methods attempt to handle a fault.</p> <p>These are the possible ways the anomaly can manifest itself:</p> <ul style="list-style-type: none"> • The controller will experience a major non-recoverable fault. I/O goes to their configured safe state, and the user application is cleared from memory. At this point, a Code 1 Type 60 or 61 major recoverable fault will be logged in the controller. This requires you to redownload the application. • Tag data corruption. • Online saving or uploading failures. • Anomalous program execution. <p>For example, if a rung is being scanned false and there is an instruction that has false execution, the fault handler executes so the remainder of the rung will scan true. In the example below, the OTE instruction has an index out of range. After returning from the fault handler, the ADD instruction will execute, even though the rung input conditions are false.</p>
