1769 CompactLogix Packaged Controllers, Revision 19

Catalog Numbers 1769-L31, 1769-L32C, 1769-L32E, 1769-L35CR, 1769-L35E

Publication 1769-RN019D-EN-P - October 2012

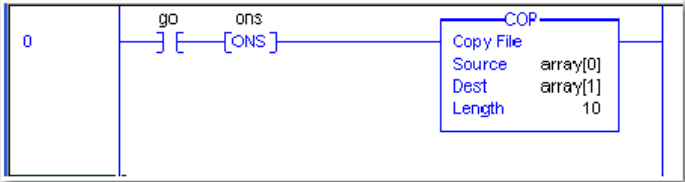
Cat. No.	Description																																																
1769-L31, 1769-L32C, 1769-L32E, 1769-L35CR, 1769-L35E	<p>CORRECTED: The Copy File (COP) Synchronous Copy File (CPS) instruction use may result in Unexpected Execution. If the COP or CPS instructions are configured so that the source and destination tags overlap, the instruction has unexpected execution. For example, these graphics show an example COP instruction and its tag values before execution.</p>

<table border="1" data-bbox="344 688 850 1037"> <thead> <tr> <th>Name</th> <th>Value</th> </tr> </thead> <tbody> <tr> <td>array</td> <td>{...}</td> </tr> <tr> <td>array[0]</td> <td>0</td> </tr> <tr> <td>array[1]</td> <td>1</td> </tr> <tr> <td>array[2]</td> <td>2</td> </tr> <tr> <td>array[3]</td> <td>3</td> </tr> <tr> <td>array[4]</td> <td>4</td> </tr> <tr> <td>array[5]</td> <td>5</td> </tr> <tr> <td>array[6]</td> <td>6</td> </tr> <tr> <td>array[7]</td> <td>7</td> </tr> <tr> <td>array[8]</td> <td>8</td> </tr> <tr> <td>array[9]</td> <td>9</td> </tr> </tbody> </table> <p>The result should be an array that contains all zeros. Instead, the result is an array that contains the values shown in this graphic.</p> <table border="1" data-bbox="344 1142 850 1486"> <thead> <tr> <th>Name</th> <th>Value</th> </tr> </thead> <tbody> <tr> <td>array</td> <td>{...}</td> </tr> <tr> <td>array[0]</td> <td>0</td> </tr> <tr> <td>array[1]</td> <td>0</td> </tr> <tr> <td>array[2]</td> <td>1</td> </tr> <tr> <td>array[3]</td> <td>2</td> </tr> <tr> <td>array[4]</td> <td>3</td> </tr> <tr> <td>array[5]</td> <td>3</td> </tr> <tr> <td>array[6]</td> <td>5</td> </tr> <tr> <td>array[7]</td> <td>6</td> </tr> <tr> <td>array[8]</td> <td>7</td> </tr> <tr> <td>array[9]</td> <td>7</td> </tr> </tbody> </table>	Name	Value	array	{...}	array[0]	0	array[1]	1	array[2]	2	array[3]	3	array[4]	4	array[5]	5	array[6]	6	array[7]	7	array[8]	8	array[9]	9	Name	Value	array	{...}	array[0]	0	array[1]	0	array[2]	1	array[3]	2	array[4]	3	array[5]	3	array[6]	5	array[7]	6	array[8]	7	array[9]	7
