SoftLogix Controllers, Version 20

Catalog Numbers 1789-L10, 1789-L30, 1789-L60

This publication describes SoftLogix 5800 controllers, version 20.04.00.

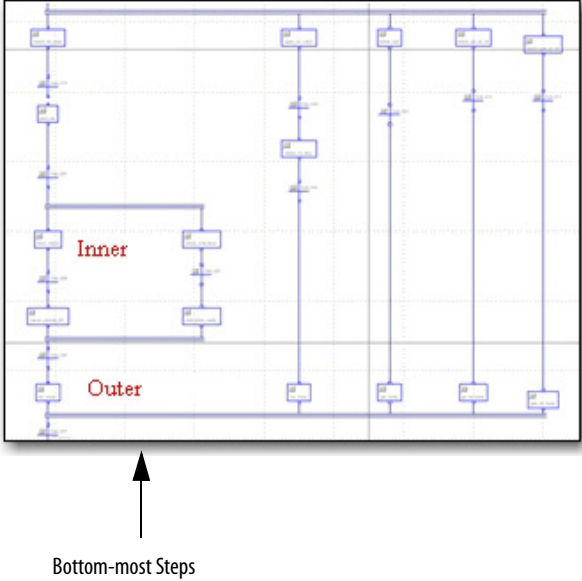
Cat. No.	Description
1789-L10, 1789-L30, 1789-L60	<p data-bbox="363 327 1360 359">CORRECTED: An anomaly can occur when you nest simultaneous branches in a Sequential Function Chart (SFC) routine as shown below.</p> <div data-bbox="386 380 964 957">

</div> <p data-bbox="363 999 1479 1100">During normal operations, the logic does not step out of a simultaneous branch until all of the incoming legs have reached their bottom-most step. In the example shown, the logic does not step out of the Outer simultaneous branch until the leftmost leg has stepped out of the Inner simultaneous branch. The first time through the SFC routine, the application works as expected. On subsequent scans, however, the chart steps out of the Outer simultaneous branch even though the left leg has not reached the Inner simultaneous branch yet.</p> <p data-bbox="363 1104 1479 1157">This behavior occurs because the information in the bottom step, that is, the step next to the word Outer, remains from the previous scan. This stale information incorrectly causes the transition to move on as if the left leg is at the bottom step when it actually is not.</p> <p data-bbox="363 1161 1479 1213">To work around this anomaly, confirm all of the incoming legs have reached their bottom steps in the transition. You can check the .x bits to make sure the bottom-most step of each converging leg is active before allowing the chart to advance. This check can be added to the transition logic already present.</p> <p data-bbox="363 1218 1479 1270">For example, the steps in the following expression are the bottom steps (see graphic above) of the incoming legs. Each step has a timer. The transition does not move on until all of the step timers have reached their preset value.</p> <p data-bbox="363 1274 1117 1295">The expression can be modified to be sure those steps are truly active. This is the original expression:</p> <pre data-bbox="386 1299 1117 1352">// Unit is ready to Transition Step1_ready.dn and Step2_ready.dn and Step3_ready.dn and Step4_ready.dn and Step5_ready.dn</pre> <p data-bbox="363 1356 829 1377">This is the modified expression to work around this anomaly.</p> <pre data-bbox="386 1381 1398 1461">// Unit is ready to Transition Step1_ready.x and Step2_ready.x and Step3_ready.x and Step4_ready.x and Step5_ready.x and Step1_ready.dn and Step2_ready.dn and Step3_ready.dn and Step4_ready.dn and Step5_ready.dn</pre> <p data-bbox="363 1465 899 1486">IMPORTANT: The x bit is cleared when the chart transitions out of a step.</p> <p data-bbox="363 1491 1479 1543">Adding this check to the condition forces the engine to wait until all of those steps are genuinely active before advancing out of the simultaneous branch. Lgx00118188, Lgx00116506</p> <hr/> <p data-bbox="363 1560 1479 1633">CORRECTED: Executing a Home Command (MAH) could cause unintended motion, equal to the negative unwind distance, when the controller executes the final offset move to the home position. The Conversion Constant and the Drive Resolution are the main contributor along with being a rotary axis. Other parameter settings that contribute to this condition are as follows:</p> <ul data-bbox="386 1638 867 1728" style="list-style-type: none"> - Home Mode = Active - Home Sequence = Marker or Switch-Marker - Home Offset = Small incremental distance (that is, 5 degrees) - Rotary Configuration with an unwind <p data-bbox="363 1732 1479 1785">To solve, upgrade to revision 20 of ControlLogix controllers, or for earlier revision periods to revision 20, set the Home Offset position to 0, use a MAM instruction to move the offset distance, then MRP (Motion Redefine Position) to the home position.</p> <p data-bbox="1268 1789 1479 1810" style="text-align: right;">Lgx00124698, Lgx00123947</p>

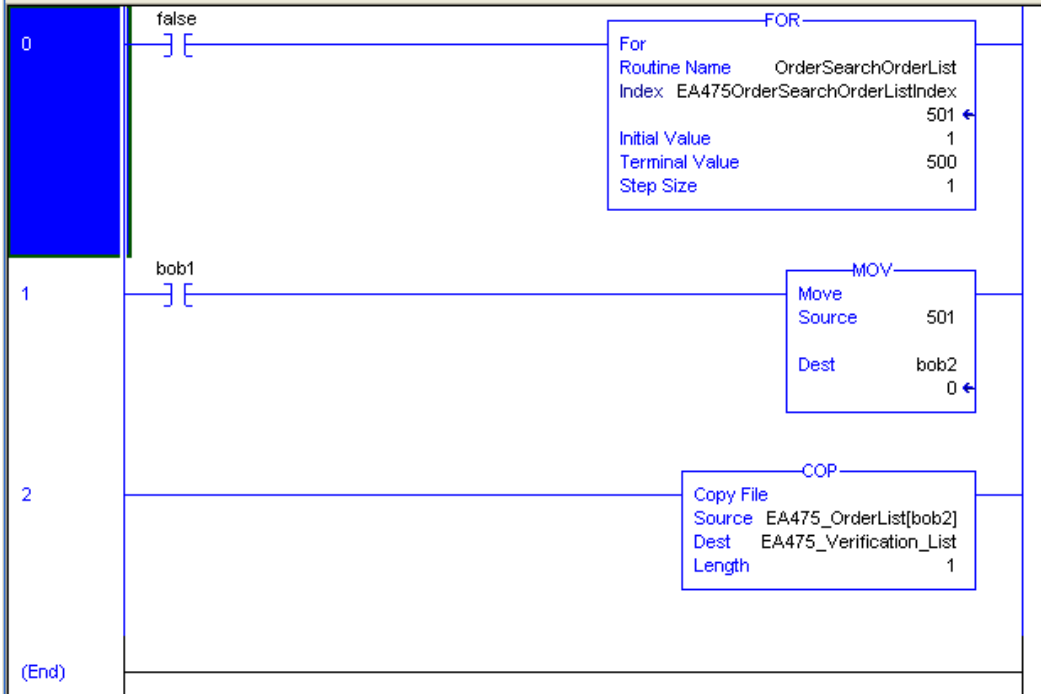
Cat. No.	Description
1789-L10, 1789-L30, 1789-L60	<p>CORRECTED: If a FOR instruction is scanned true and an instruction has an index out of range that references a UDT or multi-dimensional array, the controller will fault. Clearing the fault and returning to run mode will cause a nonrecoverable major fault.</p>
