FlexLogix Controller Revision 13 Release Notes

Cat. No. 1794-L33, 1794-L34

Publication 1794-RN013D-EN-E - September 2005

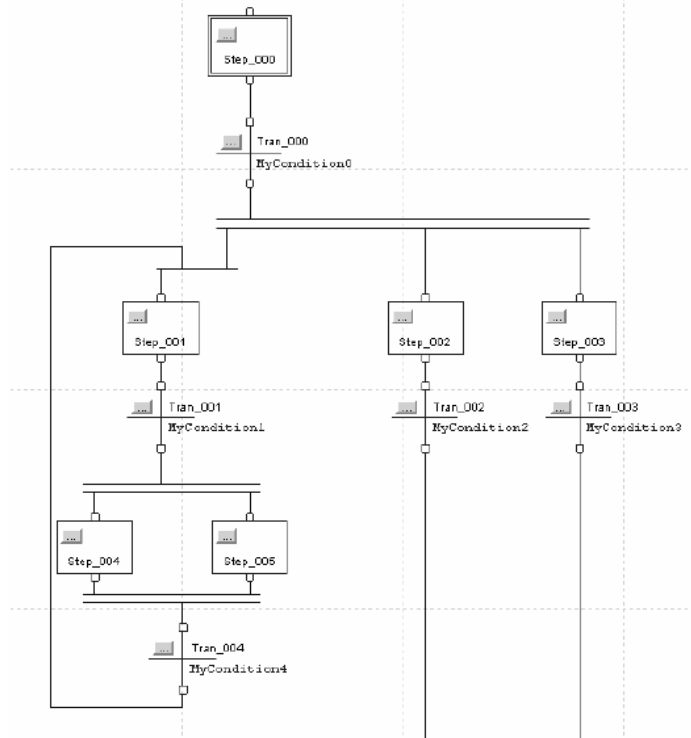
An SFC Could Execute the Wrong Step

If you had an SFC with nested simultaneous branches, the controller could begin execution at an unexpected step. Following the convergence of a nested simultaneous branch, if the SFC looped back to the initial step of the parent branch, instead of executing that step, the SFC could jump to a step of another path in the nested simultaneous branch. For example:

Execution starts at Step_000. When Tran_000 becomes true, Step_001, Step_002 and Step_003 should become active. However, because the nested simultaneous branch in the left path converged and looped back to its parent step (Step_001), the active steps were actually Step_005, Step_002 and Step_003.
