FlexLogix Controller, Revision 16

Catalog Number 1794-L34

About Publication 1794-RN016E

This revision of the firmware release notes, 1794-RN016E, provides updated information specific to firmware revision 16.22 for the FlexLogix controllers.

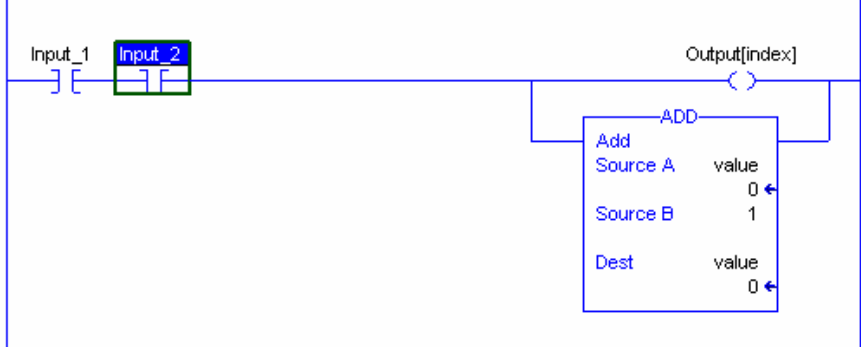
Firmware Revision	Description
16.22	<p>Fault handlers can be defined at the controller and program scope levels. These fault handlers are typically used to handle major recoverable faults that can occur during runtime execution of an application due to programming errors. A typical example of this would be handling indirect addressing that has gone out of range; MyTag[index], where index is larger than the size of the array.</p> <p>Faults can also be handled by the controller during pre-scan of the controller program on the transition to Run mode. Again, for example, the handling of indirect addressing that has gone out of range.</p> <p>There is an anomaly when these methods attempt to handle a fault.</p> <p>These are the possible ways the anomaly can manifest itself:</p> <ul style="list-style-type: none"> • The controller will experience a major non-recoverable fault. I/O goes to their configured safe state, and the user application is cleared from memory. At this point, a Code 1 Type 60 or 61 major recoverable fault will be logged in the controller. This requires you to reupload the application. • Tag data corruption. • Online saving or uploading failures. • Anomalous program execution. <p>For example, if a rung is being scanned false and there is an instruction that has false execution, the fault handler executes so the remainder of the rung will scan true. In the example below, the OTE instruction has an index out of range. After returning from the fault handler, the ADD instruction will execute, even though the rung input conditions are false.</p>

<p>Lgx00106481, Lgx00107423, Lgx00100766, Lgx00106478</p>
