ControlLogix Controllers, Revision 16

This publication describes enhancements and anomalies (known and corrected) for ControlLogix controllers, revision 16.

This revision of the firmware release notes, 1756-RN016G, provides updated information specific to firmware revision 16.023 for the following ControlLogix controllers.

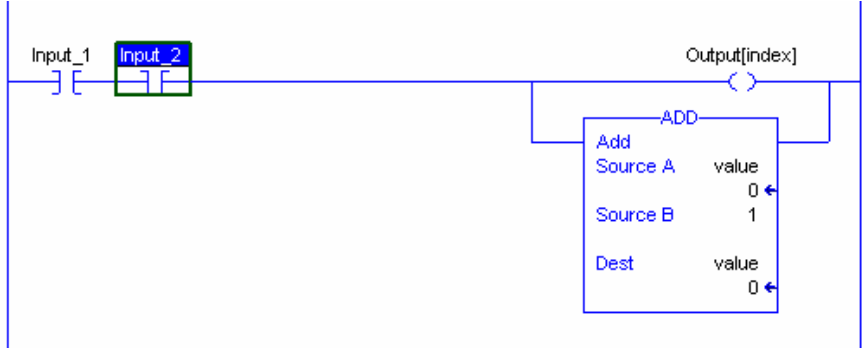
Cat. No.	Firmware Revision	Description
1756-L55Mxx, 1756-L61, 1756-L61S, 1756-L62, 1756-L62S, 1756-L63, and 1756-L64	16.022	<p>Fault handlers can be defined at the controller and program scope levels. These fault handlers are typically used to handle major recoverable faults that can occur during runtime execution of an application due to programming errors. A typical example of this would be handling indirect addressing that has gone out of range; MyTag[index], where index is larger than the size of the array.</p> <p>Faults can also be handled by the controller during pre-scan of the controller program on the transition to Run mode. Again, for example, the handling of indirect addressing that has gone out of range.</p> <p>There is an anomaly when these methods attempt to handle a fault.</p> <p>These are the possible ways the anomaly can manifest itself:</p> <ul style="list-style-type: none"> • The controller will experience a major non-recoverable fault. I/O goes to their configured safe state, and the user application is cleared from memory. At this point, a Code 1 Type 60 or 61 major recoverable fault will be logged in the controller. This requires you to redownload the application. • Tag data corruption. • Online saving or uploading failures. • Anomalous program execution. <p>For example, if a rung is being scanned false and there is an instruction that has false execution, the fault handler executes so the remainder of the rung will scan true. In the example below, the OTE instruction has an index out of range. After returning from the fault handler, the ADD instruction will execute, even though the rung input conditions are false.</p>

<p>Lgx00106481, Lgx00107423, Lgx00100766, Lgx00106478</p>
