ControlLogix Controllers, Revision 20

About This Publication

This publication describes enhancements, anomalies (corrected and known), restrictions for ControlLogix controllers, firmware revisions 20.011...20.013, and GuardLogix® controllers, firmware revision 20.011...20.013.

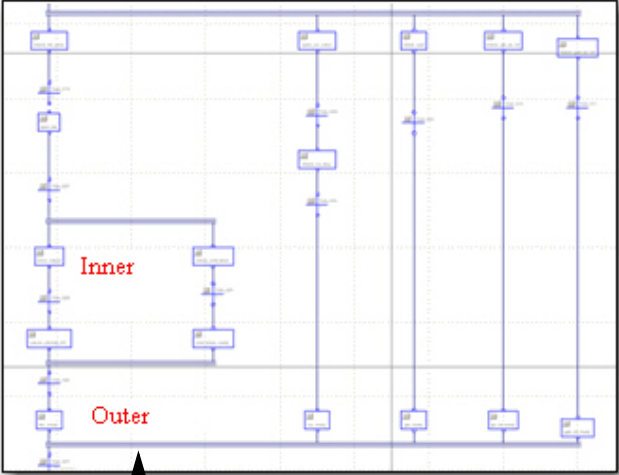
Cat. No.	Description
1756-L61 1756-L62 1756-L63 1756-L64 1756-L65 1756-L61S 1756-L62S 1756-L63S 1756-L63XT 1756-L72 1756-L73 1756-L74 1756-L75	<p>CORRECTED: An anomaly can occur when you nest simultaneous branches in a Sequential Function Chart (SFC) routine as shown below.</p>

<p style="text-align: center;">Bottom-most Steps</p> <p>During normal operations, the logic does not step out of a simultaneous branch until all of the incoming legs have reached their bottom-most step. In the example shown, the logic does not step out of the Outer simultaneous branch until the leftmost leg has stepped out of the Inner simultaneous branch. The first time through the SFC routine, the application works as expected. On subsequent scans, however, the chart steps out of the Outer simultaneous branch even though the left leg has not reached the Inner simultaneous branch yet.</p> <p>This behavior occurs because the information in the bottom step, that is, the step next to the word Outer, remains from the previous scan. This stale information incorrectly causes the transition to move on as if the left leg is at the bottom step when it actually is not.</p> <p>To work around this anomaly, confirm all of the incoming legs have reached their bottom steps in the transition. You can check the .x bits to make sure the bottom-most step of each converging leg is active before allowing the chart to advance. This check can be added to the transition logic already present.</p> <p>For example, the steps in the following expression are the bottom steps (see graphic above) of the incoming legs. Each step has a timer. The transition does not move on until all of the step timers have reached their preset value.</p> <p>The expression can be modified to be sure those steps are truly active. This is the original expression:</p> <pre>// Unit is ready to Transition Step1_ready.dn and Step2_ready.dn and Step3_ready.dn and Step4_ready.dn and Step5_ready.dn</pre> <p>This is the modified expression to work around this anomaly.</p> <pre>// Unit is ready to Transition Step1_ready.x and Step2_ready.x and Step3_ready.x and Step4_ready.x and Step5_ready.x and Step1_ready.dn and Step2_ready.dn and Step3_ready.dn and Step4_ready.dn and Step5_ready.dn</pre> <p>IMPORTANT: The x bit is cleared when the chart transitions out of a step.</p> <p>Adding this check to the condition forces the engine to wait until all of those steps are genuinely active before advancing out of the simultaneous branch.</p> <p style="text-align: right;">Lgx00118188, Lgx00116506</p> <p>CORRECTED: Applications that have a large quantity of HMI tags on scan in the controller can experience a non-recoverable major fault when doing online edits.</p> <p style="text-align: right;">Lgx00118192, Lgx00115817</p>
