# ControlLogix 5560M03SE Combination Controller and SERCOS Interface, Firmware Revision 13

Catalog Number 1756-L60M03SE

These release notes correspond to firmware revision 13.11 of the ControlLogix 5560M03SE controller.

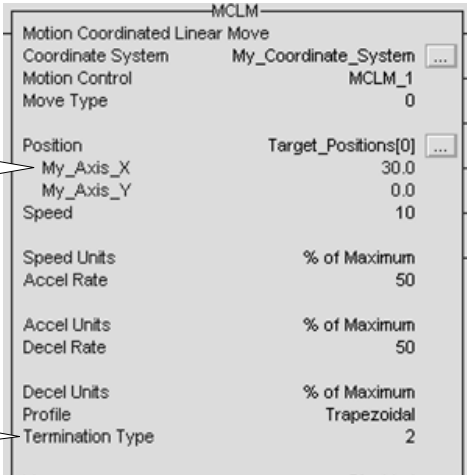
Firmware Revision	Corrected anomaly	Description
13.10	MCLM instruction sometimes caused an extra revolution when an axis was near its unwind position	<p>Sometimes a Motion Coordinated Linear Move (MCLM) instruction moved an axis an extra revolution under these conditions.</p> <div data-bbox="618 493 894 638"> <p>The axis was rotary. The move was blending with another MCLM instruction across the unwind position.</p> </div> <div data-bbox="591 793 867 863"> <p>Termination Type was 2 or 3.</p> </div>

<p>This happened because of internal round-off in the floating point calculations.</p> <p>Lgx00057176</p>

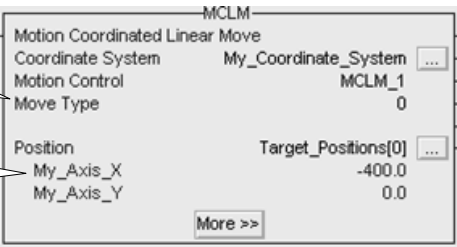
13.10	MCLM instruction did not error with a target position less than -360°	<p>A Motion Coordinated Linear Move (MCLM) instruction did not error under these conditions.</p> <div data-bbox="597 1123 873 1192"> <p>The Move Type was absolute.</p> </div> <div data-bbox="597 1220 873 1304"> <p>An axis was rotary and its target position was less than -360°</p> </div>

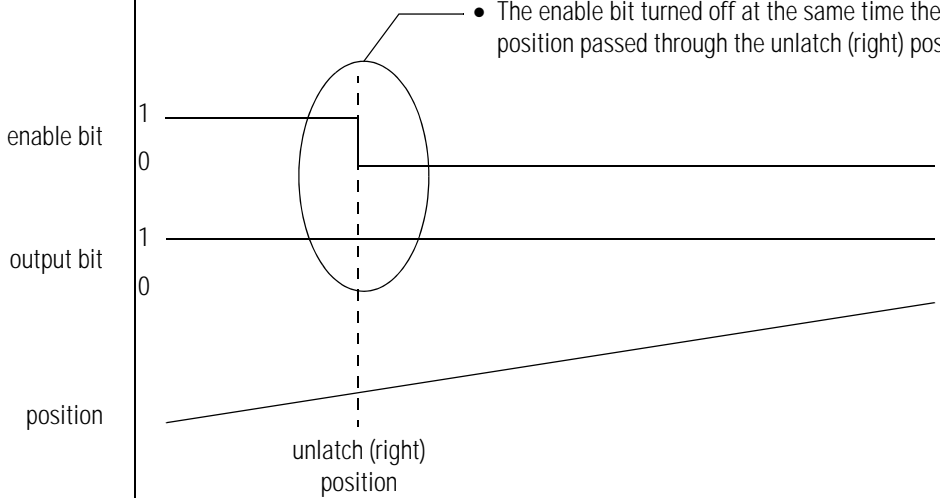
Firmware Revision	Corrected anomaly	Description
13.8	MAOC instruction left output bit on when enable bit turned off	<p>Under the following conditions, the Motion Arm Output Cam (MAOC) instruction left the output bit on when the bit should've turned off.</p> <ul style="list-style-type: none"> <li>• Unlatch type = Position and Enable</li> <li>• The enable bit turned off at the same time the position passed through the unlatch (right) position.</li> </ul>

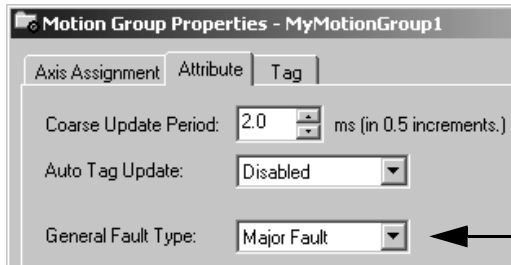
13.5	While in Program mode, a Motion Group Fault no longer produces a Major Fault	<p>As an option, you can configure a motion group to produce a <b>major fault</b> any time the group detects a motion fault.</p>

<p>With this revision, a motion group that is configured to produce a major fault produces a major fault <b>only</b> if the controller is in Run/Remote Run mode.</p> <p>In previous revisions, the motion group could produce a major fault while the controller was in Program/Remote Program mode. For example, a store to nonvolatile memory interrupts the execution of the motion planner, which produces a fault.</p> <p>Lgx00036957</p>

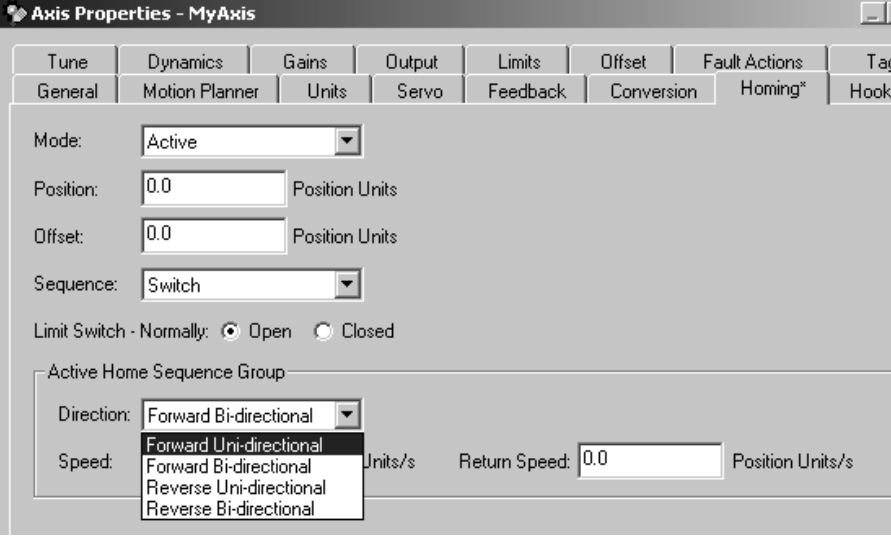
13.5	Uni-directional homing failed to complete	<p>A Motion Axis Home (MAH) instruction sometimes failed to complete (IP bit remained on) under the following axis configuration:</p> <ul style="list-style-type: none"> <li>• Return Speed = 0</li> <li>• Uni-directional homing (forward or reverse)</li> </ul>

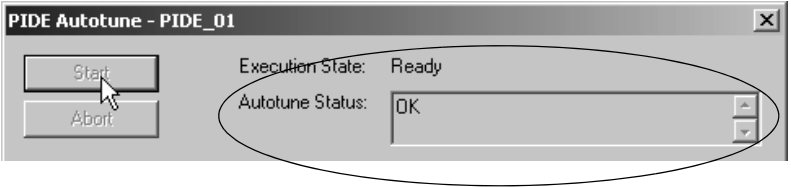
Firmware Revision	Corrected anomaly	Description
13.5	Autotune produced unnecessary warnings	<p>When you completed an autotune of an Enhanced PID (PIDE) function block instruction, the autotune status field sometimes showed warning messages that were incorrect (did not apply).</p>
