1769 CompactLogix Packaged Controllers, Revision 19

Catalog Numbers 1769-L31, 1769-L32C, 1769-L32E, 1769-L35CR, 1769-L35E

Publication 1769-RN019D-EN-P - October 2012

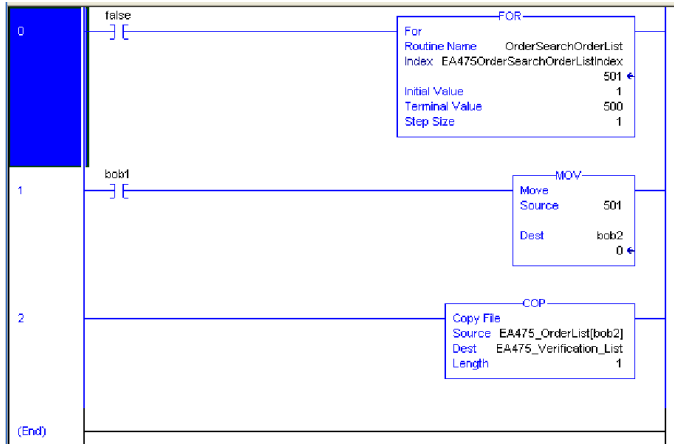
Lgx00135466, Lgx00118590

Cat. No.	Description
1769-L31, 1769-L32C, 1769-L32E, 1769-L35CR, 1769-L35E	<p>CORRECTED: If a FOR instruction is scanned true, and an instruction has an index out of range that references a UDT or a multi-dimensional array, the controller will fault. Clearing the fault and returning to Run mode will cause a non-recoverable major fault.</p>
