1336 IMPACT™ AC Drive Firmware Up-Grade Procedure

This publication will guide you through the firmware up-grade procedure of the 1336 IMPACT drive. Upgrading the 1336 IMPACT firmware is a two part process. The first step involves replacing the Language Module and the second step involves replacing the Current Processor (CP) IC.

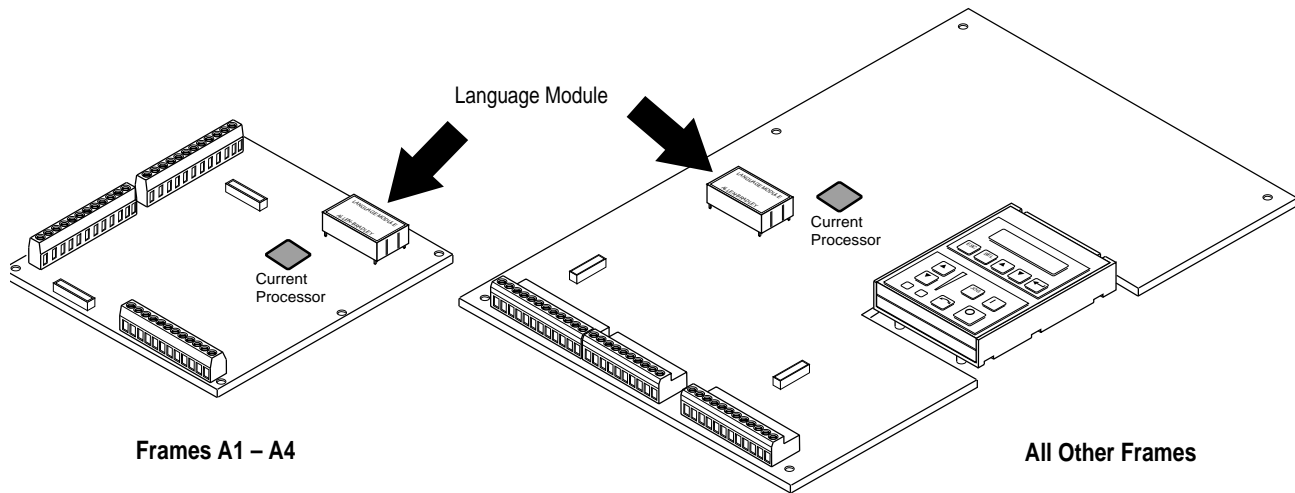
1. Remove and lock-out all incoming power to the drive cabinet.
2. Remove the front cover and verify that power has been removed from all control terminals of the drive.
3. Referring to the following figure, determine which frame size drive you have and the orientation of the Language Module and the Current Processor IC chip. On smaller drives (A-Frame) it will be

necessary to remove the cradle of the Human Interface Module. On the larger drives (B-H Frames), the Current Processor IC may be located under the GMx Module, if the drive is so equipped.

The Current Processor IC is located in the only square IC socket on the Main Control Board (MCB). This socket is located to the right and slightly above the Language Module on the B-G Frame drives. On the A - Frame drives, it is located beneath the cradle of the Human Interface Module, (HIM).

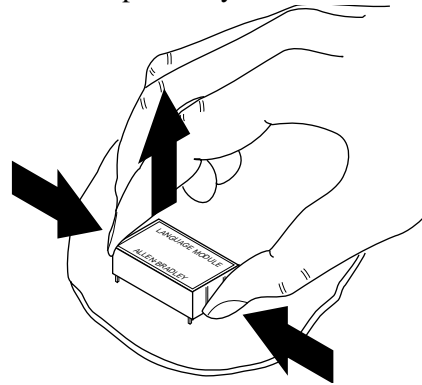
4. Locate the Language Module for your specific drive.
5. Remove the module by squeezing the sides - in, and pulling the module up & away from the MCB. Discard module.

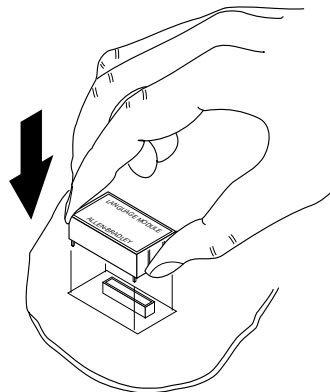
6. Position the new Language Module on the Main Control Board, using the silk screen outline on the board as a guide.
7. Carefully align the module connector with the Main Control Board connector. Firmly press the module onto the board until fully seated. The module will “snap” (lock) in place. This completes the Language Module replacement.

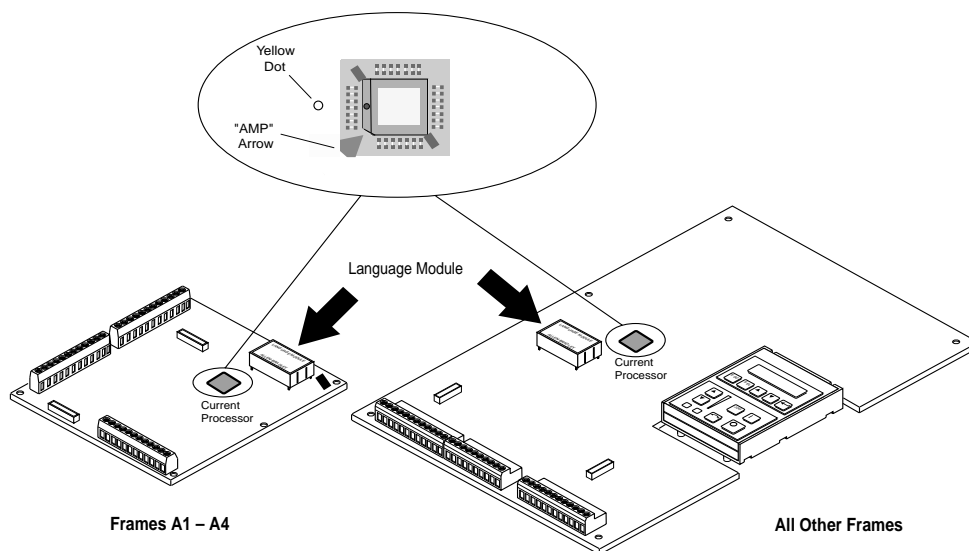
If the yellow indication dot on the board is not visible, the “AMP” imprint on the IC Socket can be used to correctly align the chip. One of the corners of the IC socket has a small arrow with the word “AMP” imprinted on it. This arrow should point to the only corner of the IC chip with a snubbed point as shown in the following illustration.

IMPORTANT: Take special note of the orientation of the processor chip in the socket. The processor chip is square and one side of the chip has a beveled edge. On the beveled edge is a small indentation to be used as a point of reference. Located on the MCB beside the IC socket is a small yellow dot that is silk screened onto the surface of the board. This small yellow dot on the board should be aligned with the indentation dot on the chip if the chip has been properly inserted.

Note: DO NOT use the manufacturer’s label on the IC chip as a reference for proper orientation of the chip. Proper orientation of the chip is critical and the location of the label may vary.
