# ControlLogix Controllers, Revision 21

## ControlLogix Controllers Catalog Numbers

1756-L71, 1756-L72, 1756-L73, 1756-L74, 1756-L75

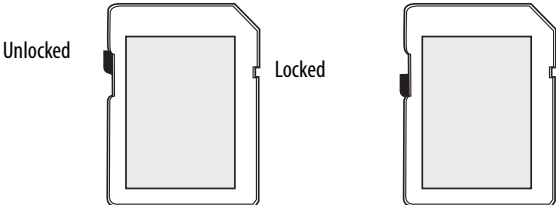
<p><b>Figure 1 - SD card - Unlocked and Locked</b></p>

<table><tr> <th data-bbox="584 751 800 793">If your SD card is</th> <th data-bbox="800 751 1472 793">Then</th> </tr><tr> <td data-bbox="584 835 800 932">Locked and the Load Image option is set to On Power Up</td> <td data-bbox="800 835 1472 932">You should unlock the SD card before beginning the upgrade. If the card is locked when you attempt to upgrade the firmware, the upgrade fails and the controller reverts to the firmware revision already stored on the SD card.</td> </tr></table>

If your SD card is	Then	Unlocked	You can successfully upgrade the firmware to the intended revision.	Locked and the Load Image option is set to On Power Up	You should unlock the SD card before beginning the upgrade. If the card is locked when you attempt to upgrade the firmware, the upgrade fails and the controller reverts to the firmware revision already stored on the SD card.
If your SD card is	Then						
Unlocked	You can successfully upgrade the firmware to the intended revision.						
Locked and the Load Image option is set to On Power Up	You should unlock the SD card before beginning the upgrade. If the card is locked when you attempt to upgrade the firmware, the upgrade fails and the controller reverts to the firmware revision already stored on the SD card.						
Your controller is close to its limits of memory	<p>This revision may require more memory than previous revisions:</p> <ul style="list-style-type: none"> <li>• To see what components of your current project require more memory, see <a href="#">page 14</a>.</li> <li>• RSLogix 5000 software, version 13.00.00 or later, lets you estimate the memory requirements of the controller offline. To upgrade to this revision, you may need to use a controller with a larger amount of memory.</li> </ul>

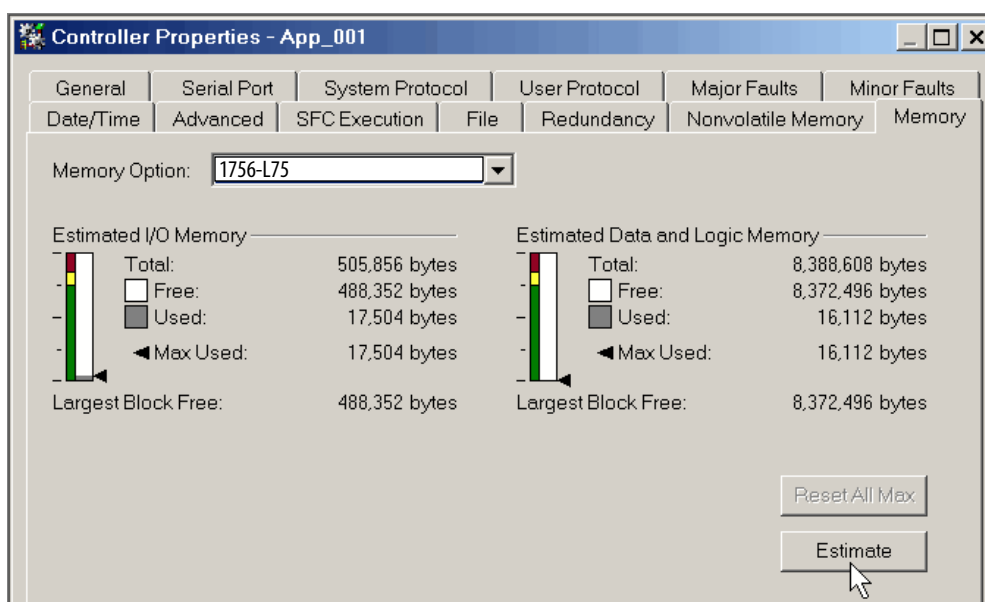
### Use the Estimate Tool

To estimate the amount of memory required by your application, convert the project to the controller revision desired and use the Estimate tool available in the Memory tab of the Controller Properties.
