ControlLogix Enhanced Redundancy System, Revision 16.081_kit5

These release notes describe enhancements, corrected anomalies, and known anomalies specific to redundancy system firmware revision 16.081_kit5 or earlier.

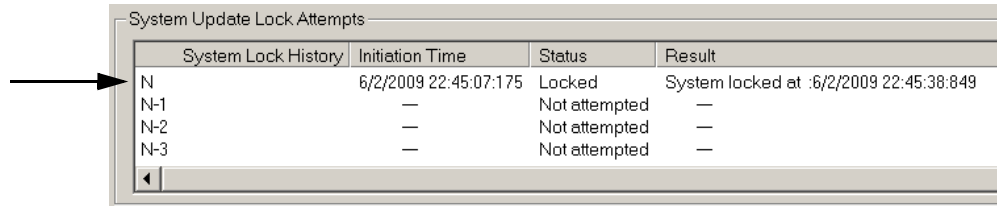
The System Update Lock Attempts log indicates when the system lock is complete.

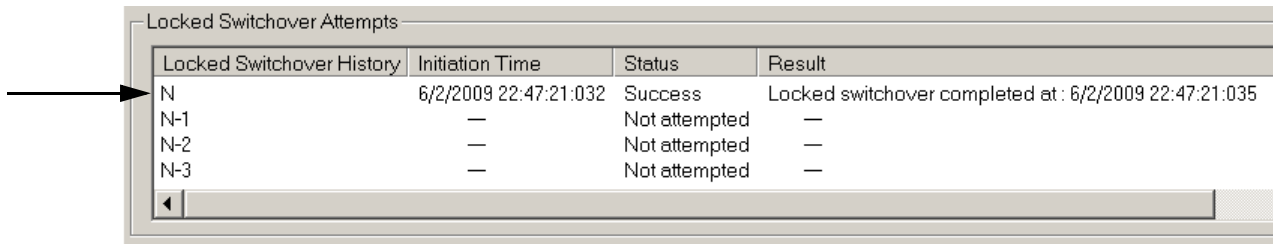
This step results in your secondary chassis assuming control and becoming the primary chassis. When the switchover is complete, the Locked Switchover Attempts log indicates success.

In addition to the log, the chassis status indicated in the bottom of the RMCT updates to reflect the switchover.

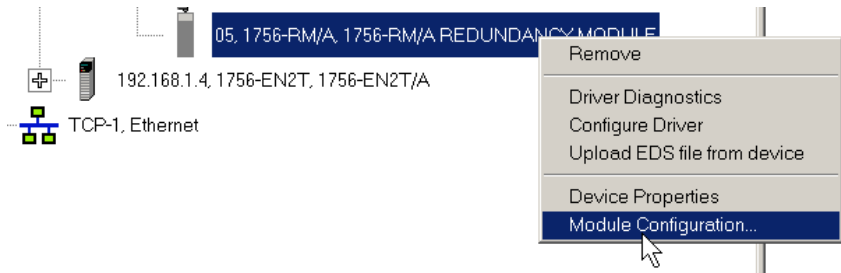
In the RSLinx Classic software, start the RMCT for the 1756-RM module in the primary chassis

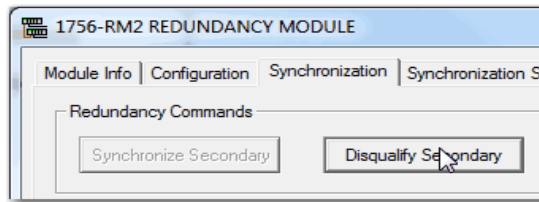
- Click Apply.
- On the Synchronization tab, click Disqualify Secondary.

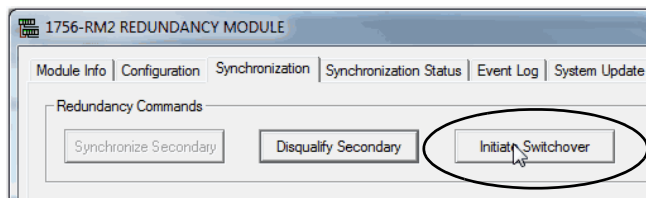
14. Initiate a switchover.

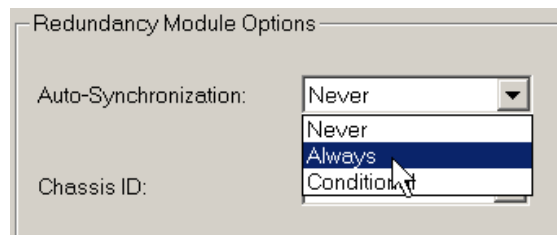
15. Turn off power to the secondary chassis.
16. Remove the 1756-EN2T module from the secondary chassis.
17. If necessary, configure the 1756-EN2T/D module with the correct IP address before inserting it into the secondary chassis.
18. Insert the 1756-EN2T/D module into the secondary chassis and turn on power to the chassis.
19. On the Configuration tab, from the Auto-Synchronization pull-down menu, choose Always.

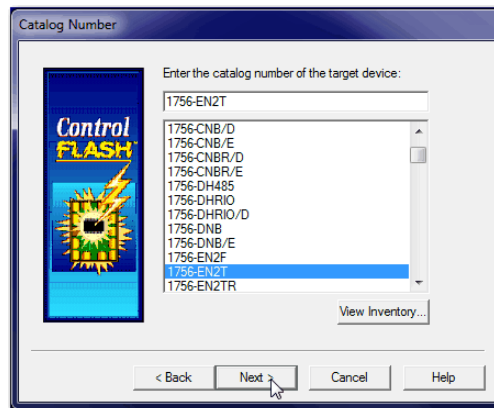
2. Verify that the new secondary 1756-EN2T/D module uses the correct firmware revision.
3. If the module firmware revision needs to be updated, we recommend that you complete the following steps in a chassis outside the RCP:
 - a. Launch ControlFLASH software and click Next.
 - b. Select 1756-EN2T and click Next.

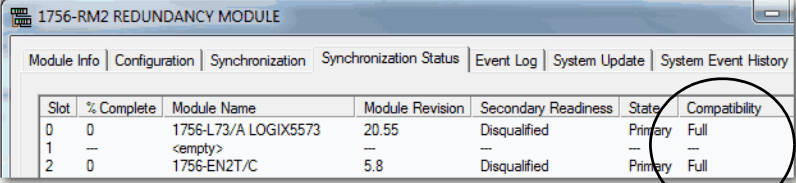
5. Connect the new 1756-EN2T/D module to the EtherNet/IP network.
6. Verify that the Synchronization Status tab indicates the modules are fully compatible.

Slot	% Complete	Module Name	Module Revision	Secondary Readiness	State	Compatibility
0	0	1756-L73/A LOGIX5573	20.55	Disqualified	Primary	Full
1	--	<empty>	--	--	--	--
2	0	1756-EN2T/C	5.8	Disqualified	Primary	Full

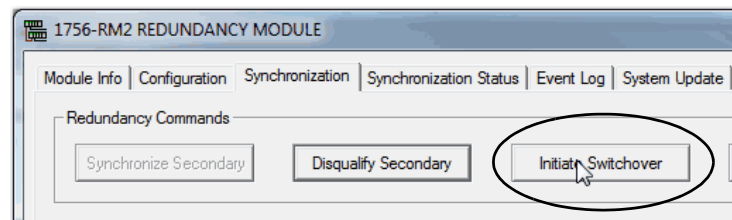
8. Initiate a switchover.

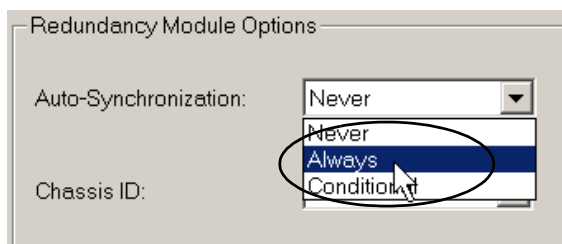
13. On the Configuration tab, from the Auto-Synchronization pull-down menu, choose Always.

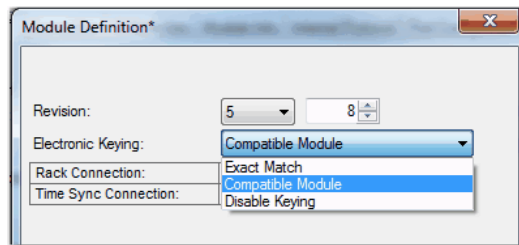
1. Make sure the existing module and replacement module use the same ControlNet node address.
2. If necessary, upgrade the recent Redundancy Module Configuration tool (RMCT).
3. If you are using a 1756-RM2, upgrade the firmware to 20.005.
4. In the RSLogix 5000 software, go online with the primary controller.
5. Verify Electronic Keying is set to Compatible Module or Disable Keying.

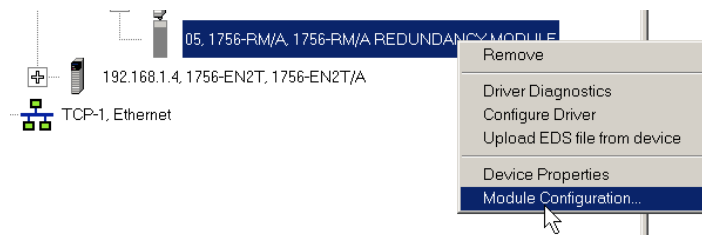
6. In the RSLinx Classic software, start the RMCT for the 1756-RM module in the primary chassis

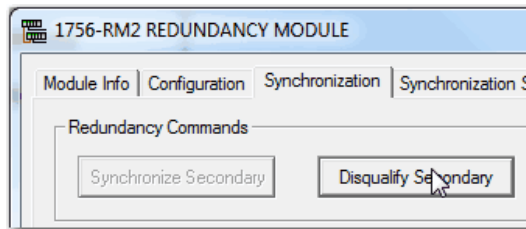
9. Click Apply.
10. On the Synchronization tab, click Disqualify Secondary.

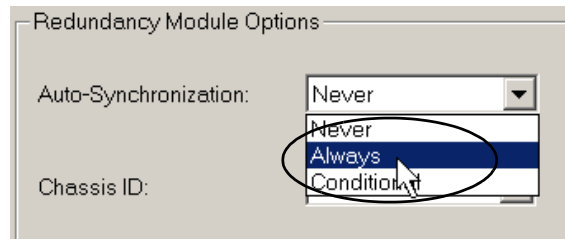
- Turn off power to the secondary chassis.
- Remove the 1756-CN2 modules from the secondary chassis.
- Make sure to match the node address of replacing the ControlNet module with existing module.
- Insert each 1756-CN2/C module into the secondary chassis, reconnect the module to the network, and turn on power to the chassis.
- If you have not already updated the firmware of the 1756-CN2/C modules, use ControlFLASH software to update the firmware of each 1756-CN2/C module in secondary chassis.
- On the Configuration tab, from the Auto-Synchronization pull-down menu, choose Always.

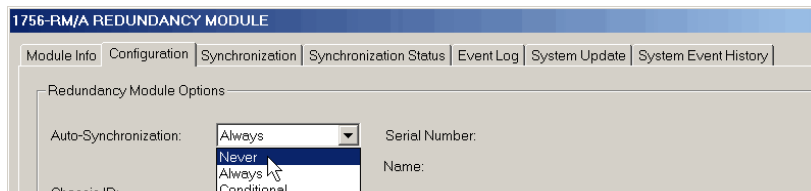
- 4. From the Auto-Synchronization pull-down menu, choose Never.

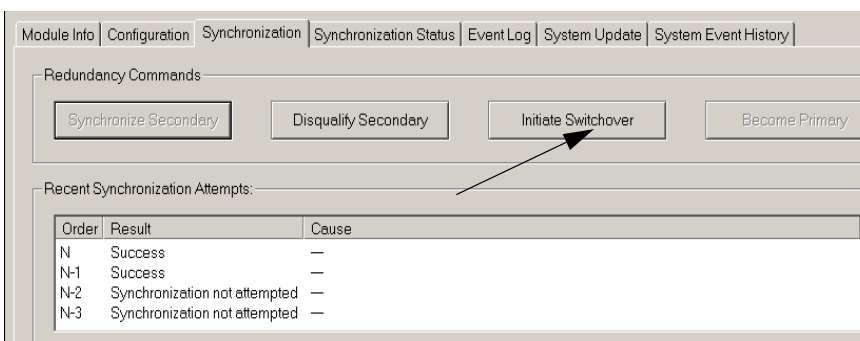
23. Click Synchronize Secondary, and then click Yes.
24. After the redundant chassis pair synchronizes, click the Synchronization tab.
25. Click Initiate Switchover, and then click Yes.

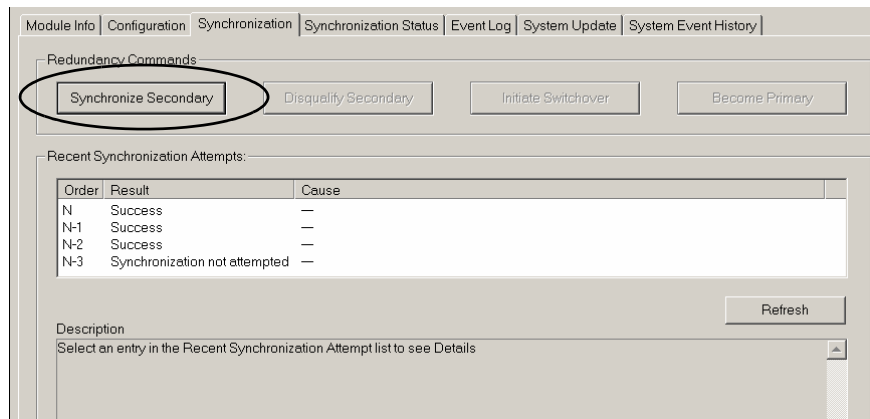
26. In the RSLinx Classic software, select Module Configuration on the new primary Ethernet communication module.
27. Click the Port Configuration tab and change the Gateway address from 0.0.0.0 to 192.168.1.1.
28. Click Apply, and then click OK.
29. Disconnect the Ethernet cable(s) from the secondary Ethernet module.
30. Reconnect the Ethernet cable(s) to the secondary Ethernet module and wait for communication to resume on the network.
31. Repeat [steps 26...30](#) for all Ethernet modules that have their rotary switches set between 2...254.
32. In RSLinx Classic software, browse to the primary 1756-RM module.
33. Right-click the primary 1756-RM module and choose Module Configuration to open the RMCT.
34. Check the Synchronization tab to verify that compatibility is Full for all modules in the chassis.
35. Click Synchronize Secondary, and then click Yes.

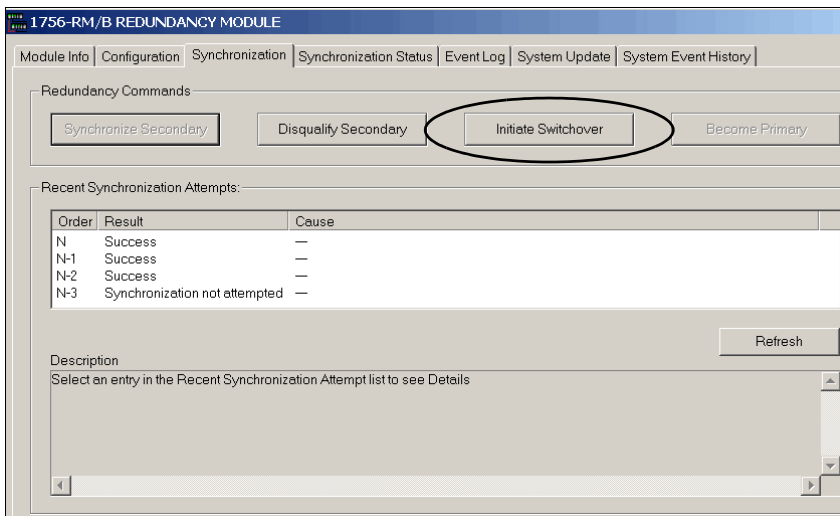
36. On the Synchronization tab click Initiate Switchover, and then click Yes.

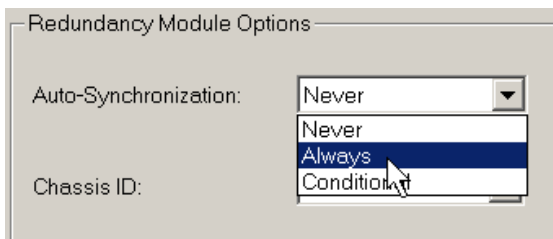
37. Remove the new secondary Ethernet module from the chassis and reset the rotary switches back to their original setting from 999.
38. Reinsert the secondary Ethernet module back in the chassis and wait until network communication resumes.
39. Check the Synchronization tab to verify that compatibility is Full for all modules in the chassis.
40. Repeat [steps 37...38](#) for all Ethernet modules that have their rotary switches set between 2...254.
41. Wait 45 seconds.
42. On the Configuration tab, from the Auto-Synchronization pull-down menu, choose Always.

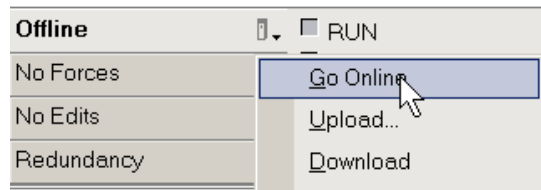
4. In RSLogix 5000 programming software, go online with the secondary controller.

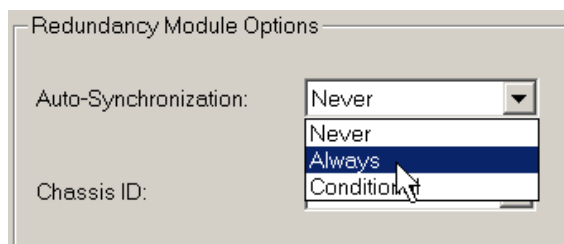
6. In the RMCT, set the Auto-Qualification parameter according to your preference.
