ControlLogix Redundancy System, Revision 15.61

Catalog Number 1756-CNB/D, 1756-CNB/E, 1756-CNBR/D, 1756-CNBR/E, 1756-ENBT, 1756-EWEB, 1756-L55, 1756-L55M12, 1756-L55M13, 1756-L55M14, 1756-L55M16, 1756-L55M22, 1756-L55M23, 1756-L55M24, 1756-L61, 1756-L62, 1756-L63, 1757-SRM

About This Publication

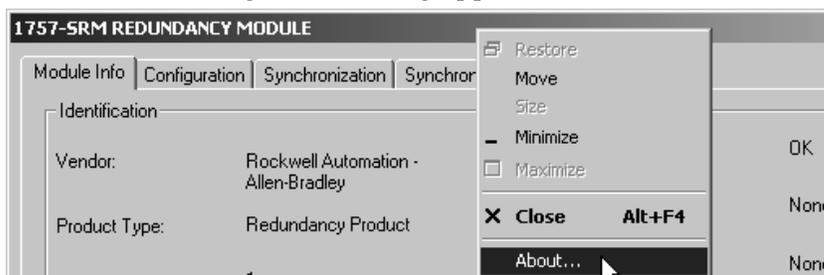
The Module Configuration dialog appears.

4. Right-click the title bar and choose About to verify the version of your configuration tool.

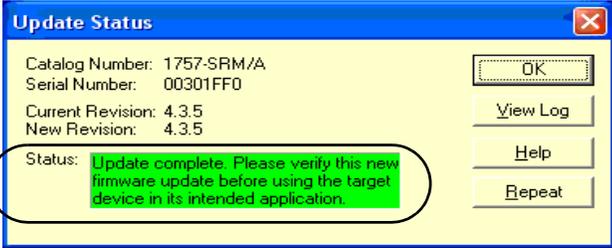
Wait until you see this box turn green and say Update complete.

If the update fails, leave the power on and try again. The update failed if you see:

- the Update Status window turn red and say the update failed.
- that the OK LED indicator on the 1757-SRM module is flashing and the four-character display is blank.

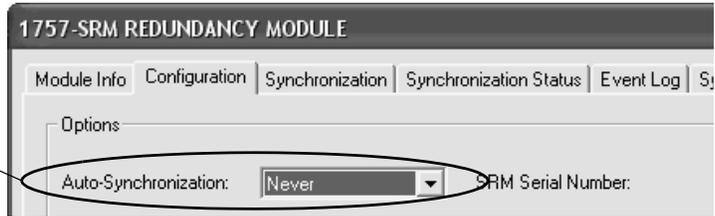
5. Disqualify the secondary chassis,

- A. Click the Configuration tab.
- B. From the Auto-Synchronization pull-down menu, choose Never.

- C. Click Apply and then Yes.
- D. Select Synchronization.

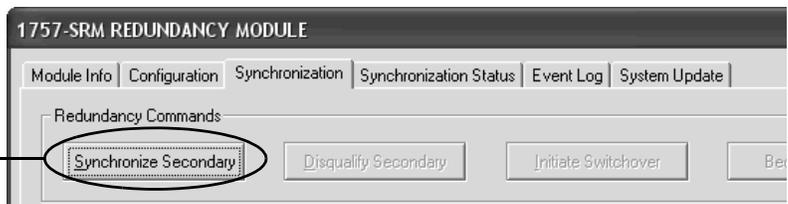
7. Synchronize the chassis.

- A. Go to the 1757-SRM configuration tool.

- B. Select Synchronize Secondary and choose Yes.

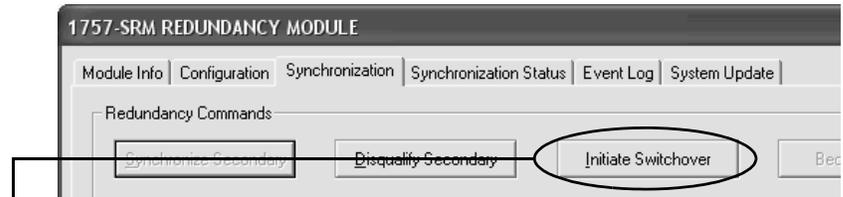
8. Initiate a switchover.

A. Select Initiate Switchover and choose Yes.

B. Wait for the system to switchover.

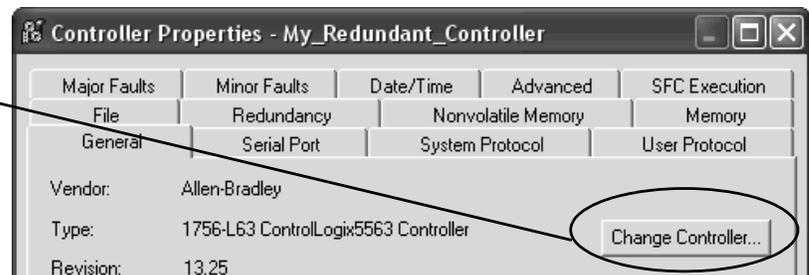
C. Select Change Controller to update the controller's type and revision.

Example: Change the controller from revision 13 to revision 15.

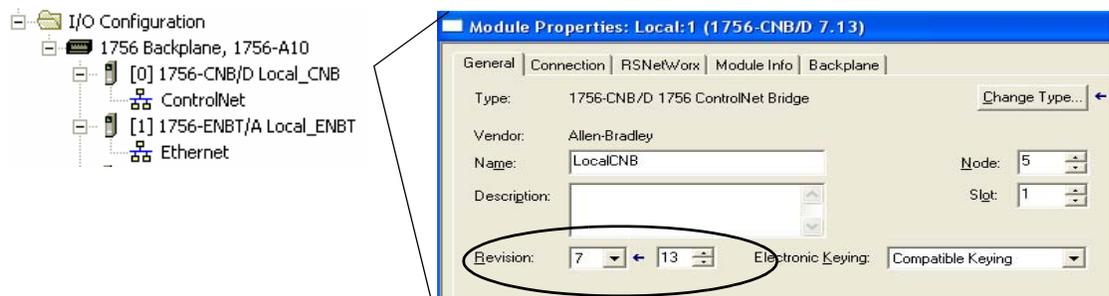
D. Change the revision of each local communication module to match what its revision will be after you update its firmware.

Example: Suppose you plan to update the firmware of each 1756-CNB series D module in the redundant chassis to revision 7.13. In that case, open the properties for each 1756-CNB series D module in the chassis and set the revision to 7.13.

Note: If you cannot select the new revision, then, from the Electronic Keying pull-down menu, choose either Compatible Keying or Disable Keying.

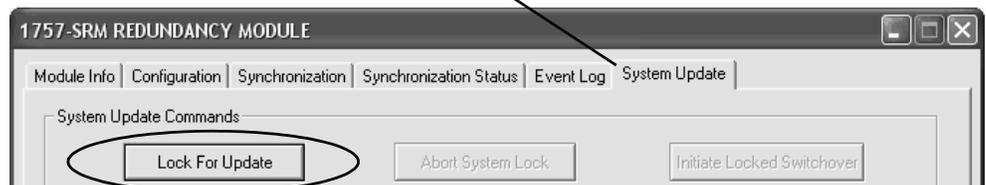
13. Lock the system for update.	<p>Important: Do not abort a system lock. Otherwise, you will clear the project from the secondary controller.</p> <p>Important: Do not remove any communication cables while you are locking the system for update.</p> <p>A. Open the 1757-SRM module configuration tool for the primary chassis.</p> <p>B. Click the System Update tab.</p>

C. Select Lock For Update and choose Yes.

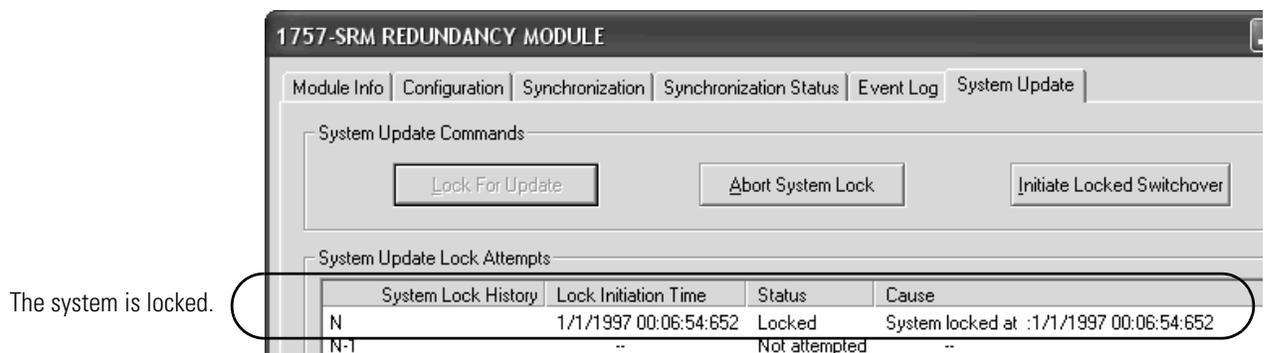
D. Wait for the system to lock.

It takes longer than a normal synchronization.

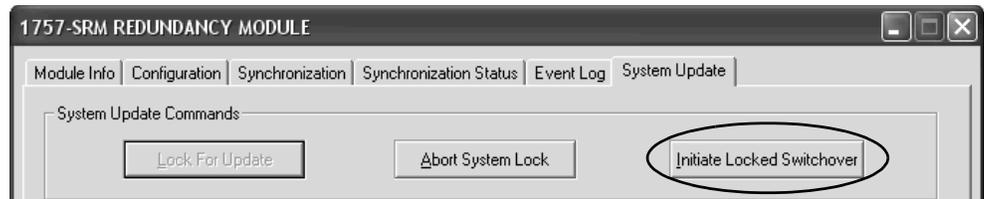
14. Initiate a Locked Switchover.

A. Select Initiate Locked Switchover and choose Yes.

B. Wait for the system to switchover. A locked switchover takes about as long as a normal switchover.

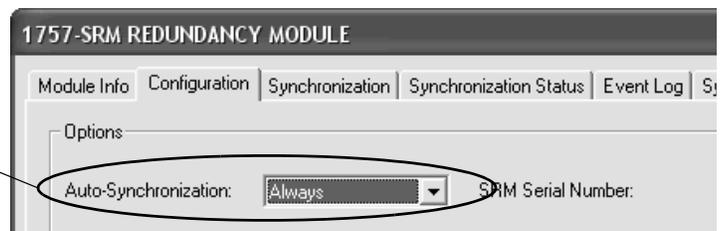
C. From the Auto-Synchronization pull-down menu, choose the desired option.

D. Click Apply and then Yes.

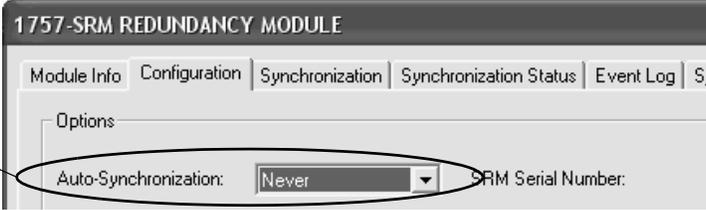
Step	Details
4. Disqualify the secondary chassis,	<p>A. Click the Configuration tab.</p> <p>B. From the Auto-Synchronization pull-down menu, choose Never.</p>

<p>C. Click Apply and then Yes.</p> <p>D. Select Synchronization.</p>

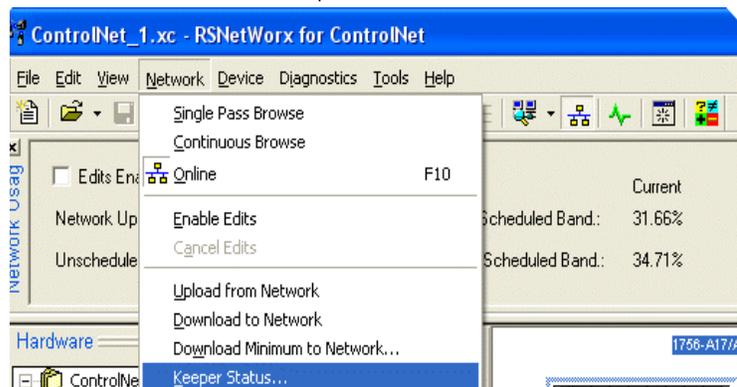
Step	Details
7. Replace the 1756-CNB modules in the secondary chassis.	<p>Replace the 1756-CNB modules in the secondary chassis with series E modules. As you replace the modules:</p> <ul style="list-style-type: none"> · make sure that you set each module to the same address as the module that it is replacing. · make sure that you connect the correct ControlNet tap. To avoid connecting the wrong tap, replace the modules one at a time and reconnect the ControlNet tap.
8. Update the keeper signatures of the 1756-CNB modules.	<p>A. Start RSNetWorx for ControlNet software, and open the network configuration file. B. Go online with the network. You do not have to browse the entire network. C. Select Network and choose Keeper Status.</p>

- D. Select the node number of the secondary 1756-CNB module and click Update Keeper.

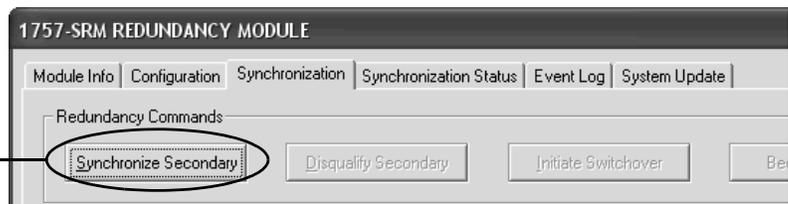
10. Synchronize the secondary chassis.
- A. Select Synchronization.

- B. Select Synchronize Secondary and choose Yes.
- C. Wait for the chassis to synchronize.

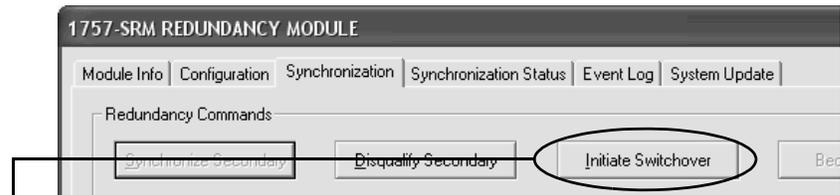
11. Initiate a switchover.

Select Initiate Switchover and choose Yes.

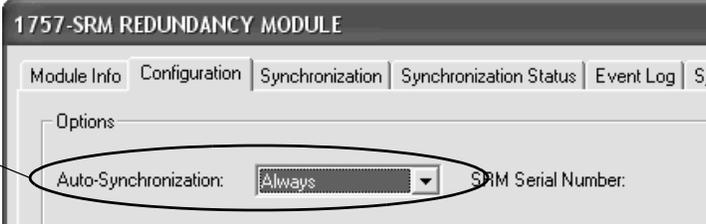
Step	Details
13. Synchronize the chassis.	<p data-bbox="646 289 1354 317">A. Go to the 1757-SRM module configuration tool for the primary chassis.</p> <p data-bbox="646 346 951 373">B. Select the Configuration tab.</p> <p data-bbox="646 403 1398 430">C. From the Auto-Synchronization pull-down menu, choose the desired option.</p> <div data-bbox="771 464 1477 688">

</div> <p data-bbox="646 716 867 743">D. Click Apply and Yes.</p>
