SoftLogix Controllers, Version 18.02

Catalog Numbers 1789-L10, 1789-L30, 1789-L60

This publication describes enhancements, anomalies (known and corrected), and restrictions for SoftLogix controllers, version 18.00 and later.

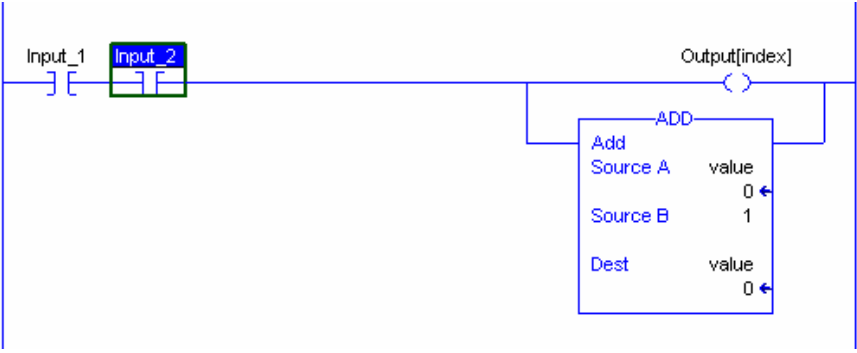
Cat. No.	Description
	<p>Fault handlers can be defined at the controller and program scope levels. These fault handlers are typically used to handle major recoverable faults that can occur during runtime execution of an application due to programming errors. A typical example of this would be handling indirect addressing that has gone out of range; <code>MyTag[index]</code>, where <code>index</code> is larger than the size of the array.</p> <p>Faults can also be handled by the controller during pre-scan of the controller program on the transition to Run mode. Again, for example, the handling of indirect addressing that has gone out of range.</p> <p>There is an anomaly when these methods attempt to handle a fault.</p> <p>These are the possible ways the anomaly can manifest itself:</p> <ul style="list-style-type: none"> • The controller will experience a major non-recoverable fault. I/O goes to their configured safe state, and the user application is cleared from memory. At this point, a Code 1 Type 60 or 61 major recoverable fault will be logged in the controller. This requires you to redownload the application. • Tag data corruption. • Online saving or uploading failures. • Anomalous program execution. <p>For example, if a rung is being scanned false and there is an instruction that has false execution, the fault handler executes so the remainder of the rung will scan true. In the example below, the OTE instruction has an index out of range. After returning from the fault handler, the ADD instruction will execute, even though the rung input conditions are false.</p>

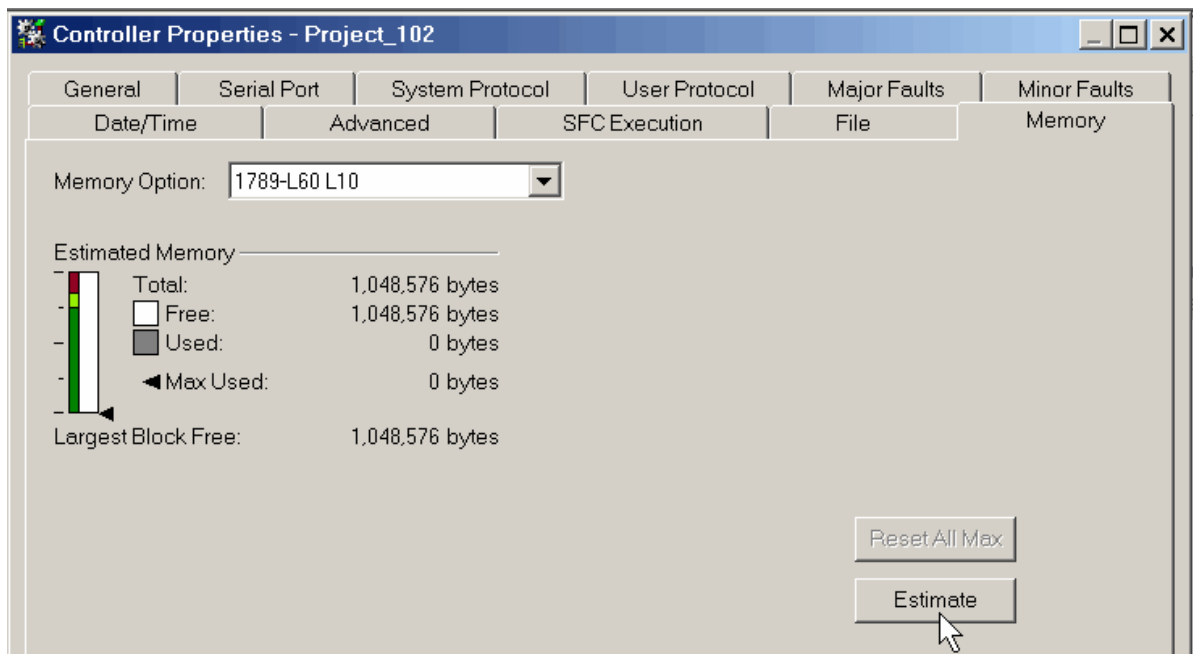
Use the Estimate Tool

To estimate the amount of memory required by your application, convert the project to the controller revision desired and use the Estimate tool available in the Memory tab of the Controller Properties.
