SoftLogix 5800 Controllers, Version 19.01

Catalog Numbers 1789-L10, 1789-L30, 1789-L60

This publication describes enhancements, anomalies (known and corrected), and restrictions for SoftLogix 5800 controllers, version 19.00 and later.

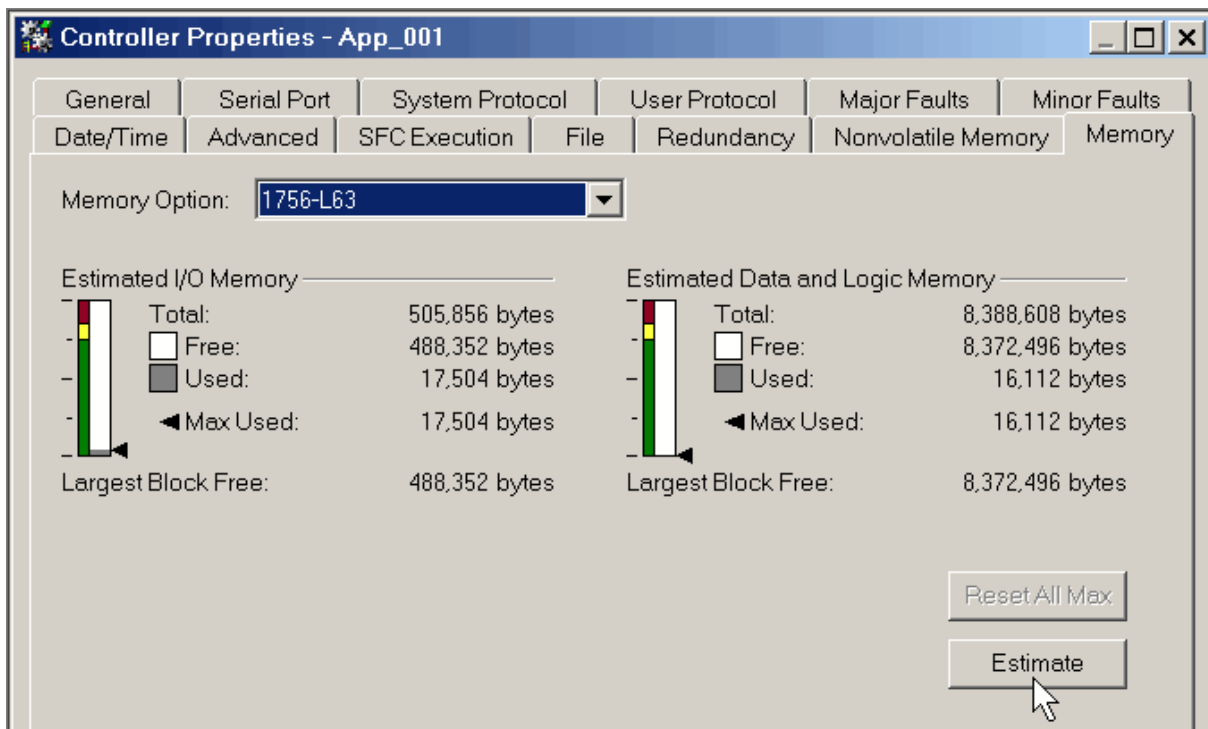
Use the Estimate Tool

To estimate the amount of memory required by your application, convert the project to the controller version desired and use the Estimate tool available in the Memory tab of the Controller Properties.
