FlexLogix Controller Revision 11

Cat. No. 1794-L33, 1794-L34, and 1794-L34/B

These release notes should be used with major revision 11, minor revision 26 of the FlexLogix Controller firmware. Use this firmware with:

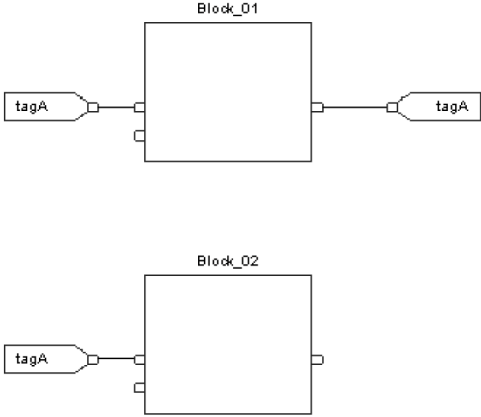
Change:	Description:
<p>Use the Same Tag in Multiple IREFs and OREFs</p>	<p>You can use the same tag in multiple IREFs and an OREF in the same routine. Because the values of tags in IREFs are latched every scan through the routine, all IREFs will use the same value, even if an OREF obtains a different tag value during execution of the routine. In this example, if tagA has a value of 25.4 when the routine starts executing this scan, and Block_01 changes the value of tagA to 50.9, the second IREF wired into Block_02 will still use a value of 25.4 when Block_02 executes this scan. The new tagA value of 50.9 will not be used by any IREFs in this routine until the start of the next scan.</p> <div style="text-align: center;">

<p>The diagram illustrates two control blocks, Block_01 and Block_02. Block_01 is a square with an input terminal on the left labeled 'tagA' and an output terminal on the right labeled 'tagA'. Block_02 is a square with an input terminal on the left labeled 'tagA' and an output terminal on the right. This setup demonstrates how a tag's value is latched at the start of a scan and used by all IREFs within that scan, even if the tag's value changes during the scan.</p> </div>
