## PowerFlex 700H Drive (Revision 1.006)

These release notes correspond to minor revision 1.006 of firmware for PowerFlex 700H Drives.

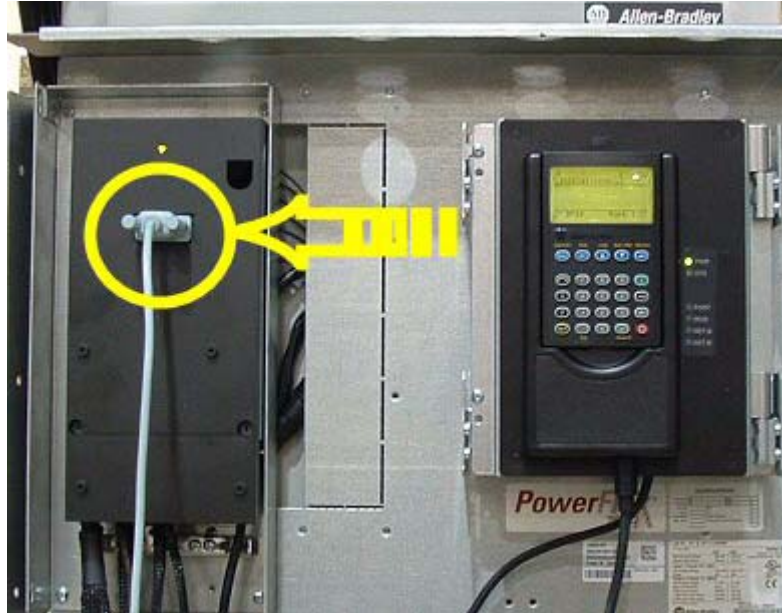
1. Connect the serial cable to the port on the front of the 700H control assembly as shown below.

**Important:** The PowerFlex Flash Upgrade Tool is used with a straight serial cable with male-female connectors. Do not use a crossover cable (NULL Modem) cable.
