# Enhanced PLC-5 Programmable Controller Firmware Upgrade

(Catalog Numbers 1785-L11B, -L20B, -L30B, -L40B, -L40L, -L60B, -L60L, -L80B)

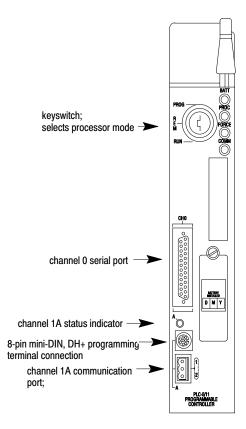
- 1 Save processor memory using the programming software.
- 2 Remove the battery cover and disconnect the battery.

Remove the phillips head screw near the channel 1B LED and gently remove the channel 1 communication plug. Be aware that the memory grounding clip may move or drop off from the cover mounting tab.
- Skip this step if you have a PLC-5/11 or -5/20 processor.

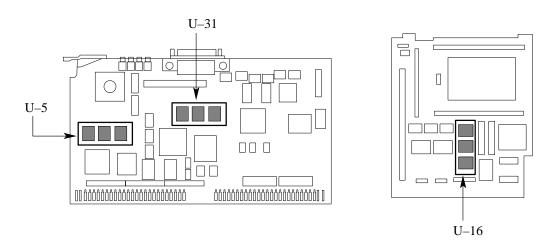
Example (for PLC-5/40, -5/60, and -5/80 series A, B, and C processors)

Observe the orientation of the pin 1 indicators before you remove each PROM. Replace each of the indicated PROMS, checking to see that the pin 1 indicators are correctly oriented.

For this processor:	Replace these PROMs:
PLC-5/11 and -5/20 series A and C	U70 and U61
PLC-5/30 series A and C	U5 and U31
PLC-5/40, -5/60, and -5/80 series A, B, and C	U5, U16 or U13, and U31
