Micro800 Programmable Controllers

Catalog Number Bulletin 2080, firmware revision 11 or later

About This Publication

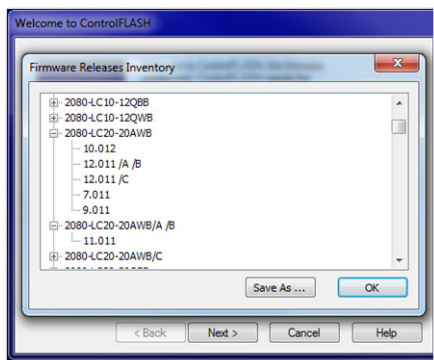
IMPORTANT When using ControlFLASH, if you are updating your controller firmware to revision 11, select the firmware from the catalog number with series information (for example, 2080-LC20-20AWB/A /B). For all other versions, select the firmware from the catalog number without series (for example, 2080-LC20-20AWB).
