iTRAK System

Bulletin Number 2198T-L16

Troubleshooting Guide

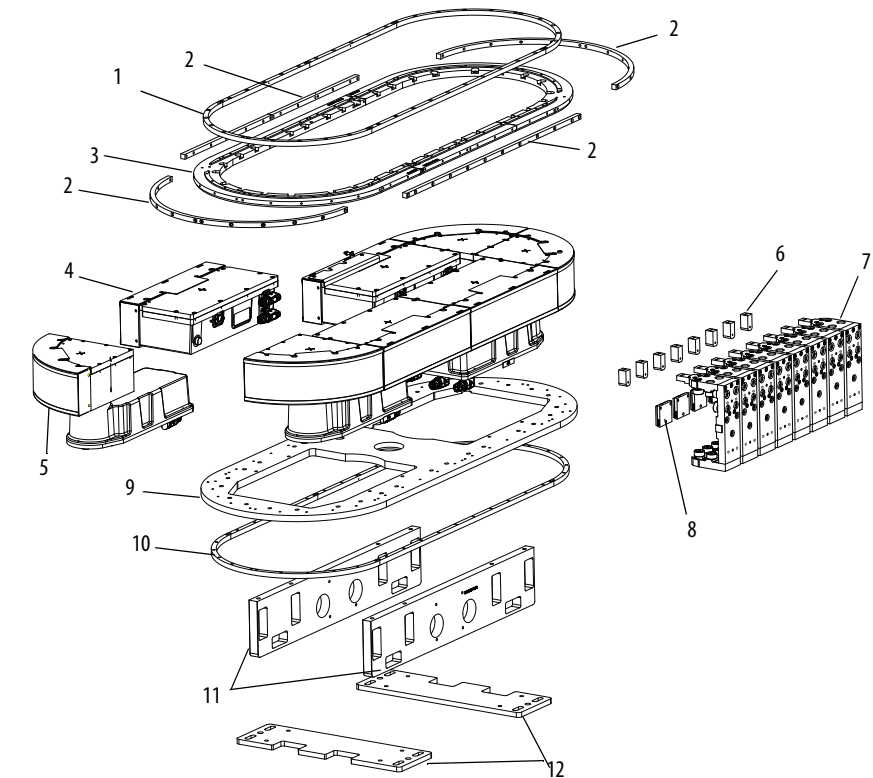
Mechanical iTRAK components

An exploded view of the mechanical and servo components of an iTRAK system is displayed in the following diagram. Familiarize yourself with the nomenclature and use of each component.

Item	Description
1	Top bearing rail
2	Transverse bearing rail
3	Top frame plate
4	Straight motor modules
5	Curved motor modules
6	Position magnets

Item	Description
7	Movers
8	Mover magnets
9	Bottom frame plate
10	Bottom bearing rail
11	Spine bars
12	Mounting plate

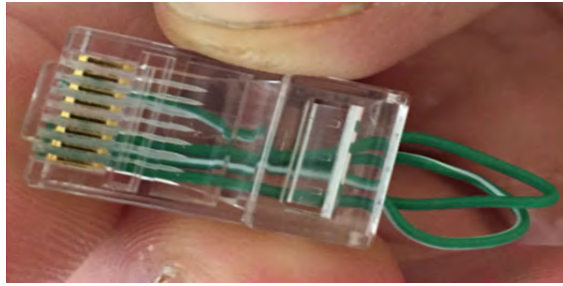
The gateway provides centralized motion processing and communication between the controller and the motor modules. There are three generations of gateways, which all provide the same function, however, there are some differences:

- Gen 1 and Gen 2 require a loopback connector after the last communication cable if all ports are not occupied by communication cable. (Gen 3 doesn't require a loopback connector)

- The Compact Flash card used on Gen 1 is different than CFast card Gen 2 and Gen 3 utilize therefore they cannot be used interchangeably.

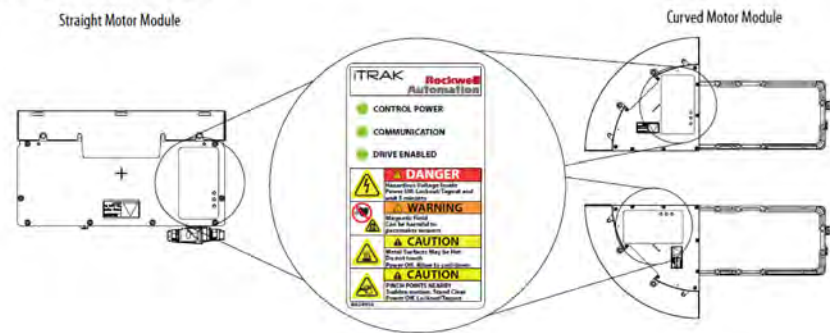
Series B Motor Module Status Indicators

Control Power or Communication LED Off

If you do not have any LED illuminated, including Control Power, this indicates that you have no power to the iTRAK system or particular motors. Follow these steps to diagnose power:

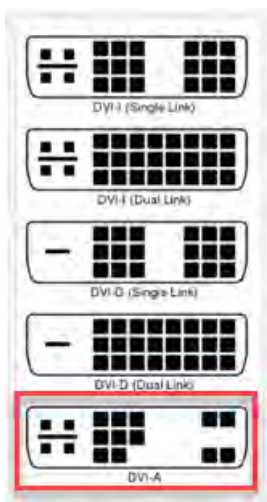
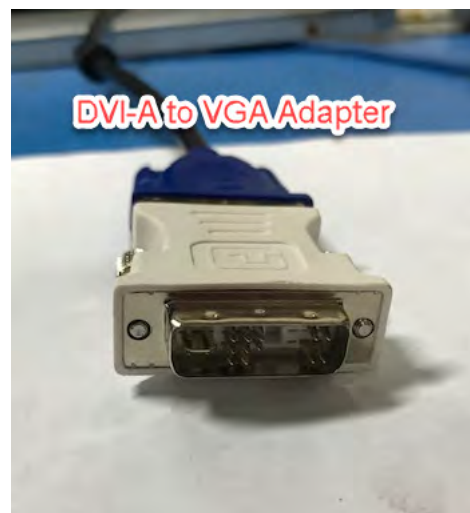
1. Connect a monitor with a DVI connector to the gateway.
2. If the monitor has a VGA connector, use an adapter VGA to DVI in order to connect to the gateway.

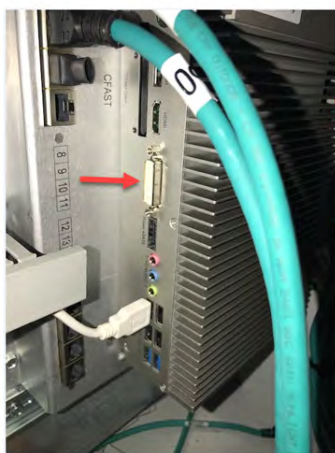
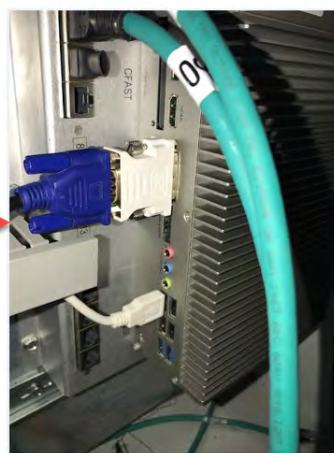
3. Connect the DVI-A male end from your computer monitor into the DVI plug on the gateway.

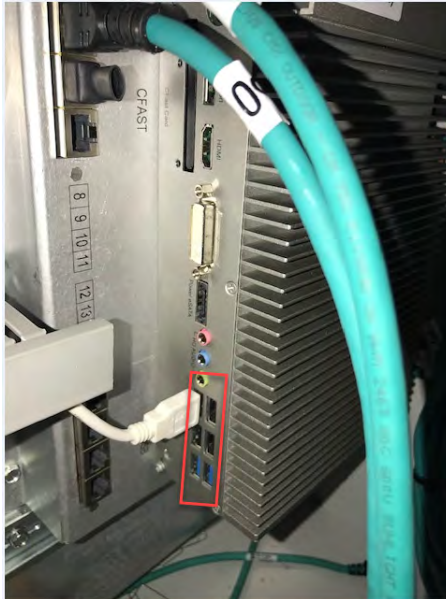
4. Connect a keyboard to any one of the free USB ports in the gateway.

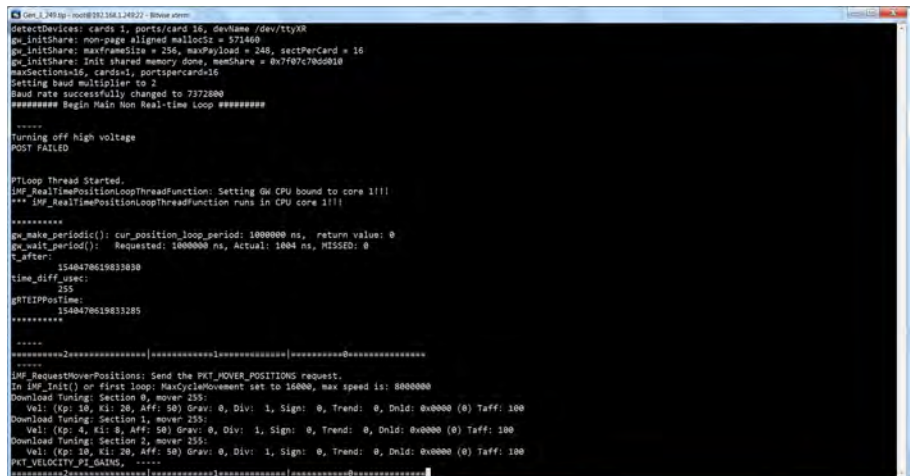
6. The screen display a screen similar to the one shown.

Section o has a section type that does not match. Section o is type 6 which is a 50 mm optimal force, while the rest of the track is 100 mm optimal current.

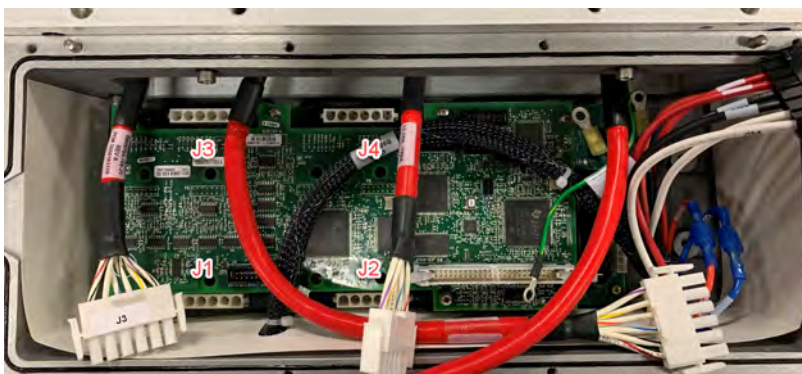
3. Verify motor shorts:
 - a. Before you enable the system, move one mover around the track and make sure the continuous push force is 3...7 lb, and consistent all the way around.
 - b. If there is a short in one or more motors, it requires more force to move a mover and the cogging of the magnet/coils can be felt. To confirm the motor is shorted, complete the following steps:
 - Remove the white position board cover from the module.
 - Unplug the 4 connectors J1, J2, J3, and J4 from the power board.

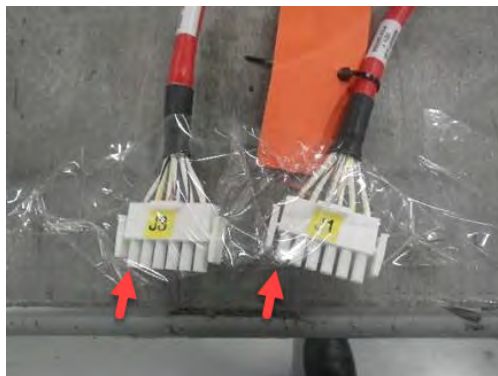
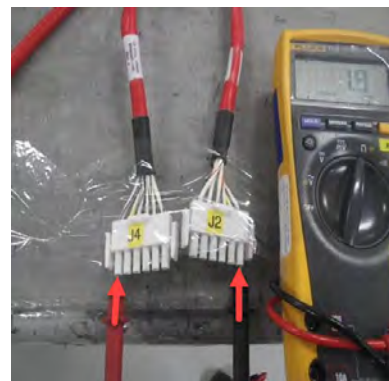
4. To confirm a shorted coil, check the resistance of the same color wires in the groups below:
 - J1 and J3
 - J2 and J4

Resistance should measure $1.9\ \Omega$ or very close to it. Check all six wires on both sets. All readings should be the same.

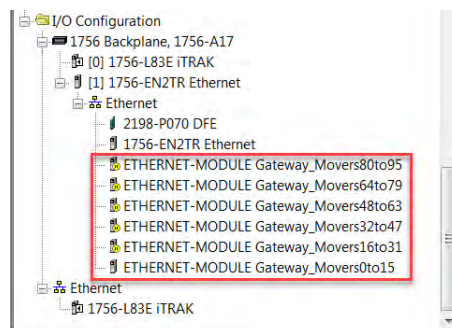
1. Locate the Ethernet modules in the I/O configuration.

The number of movers on the system determines how many of the Ethernet modules you use.

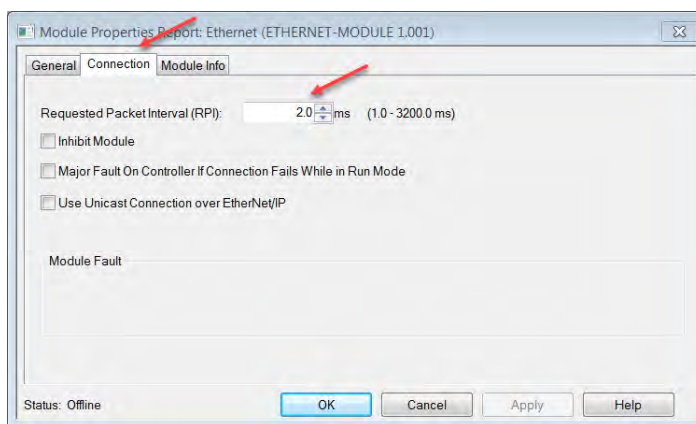
2. To view or set the RPI, right click on each of the modules you are using and select properties.
3. Click the connection tab and set the RPI to the appropriate number based on the PLUP, and click Apply.

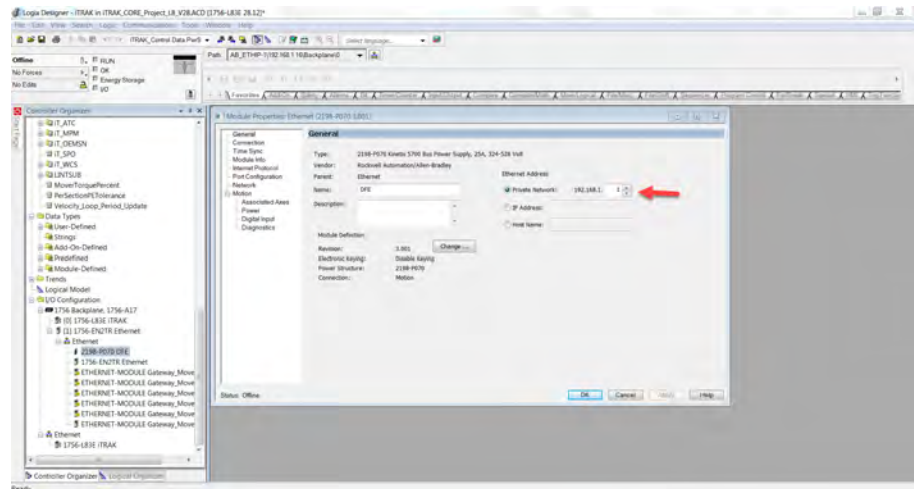
3. Expand I/O Configuration, right click the DFE line, and select properties.

4. Set the following parameters for the DFE properties:
 - IP Address – Set the IP address of the DFE.

Note: This is not the Kinetix® 5700 iTRAK Power Supply (iPS). The iPS does not belong in the Ethernet tree. All communication between the PLC, gateway, and power supply occurs through the DFE.

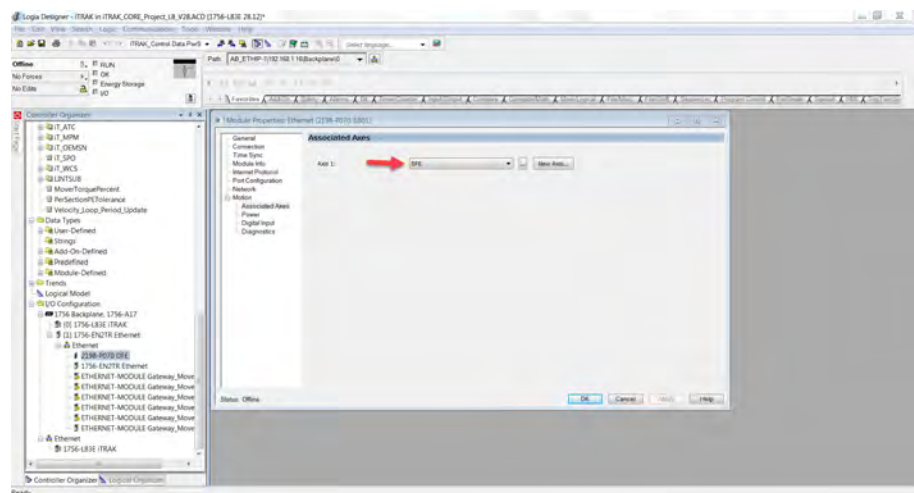
5. On the Associated Axes tab, make sure that Axis 1 is set to DFE (or whatever you named it in the motion group).

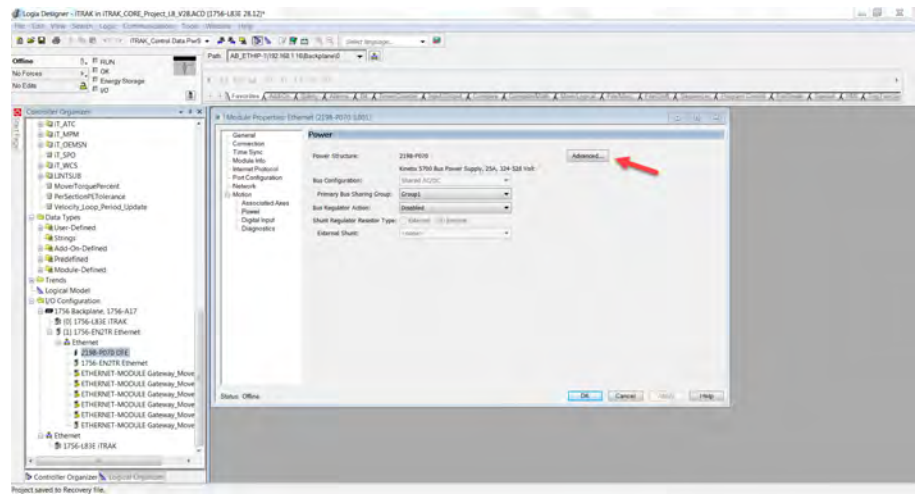
6. On the Power tab, verify that the following parameters are set:
 - Primary Bus Sharing Group is set to Group 1.
 - Bus Regulator Action is set to Disabled.

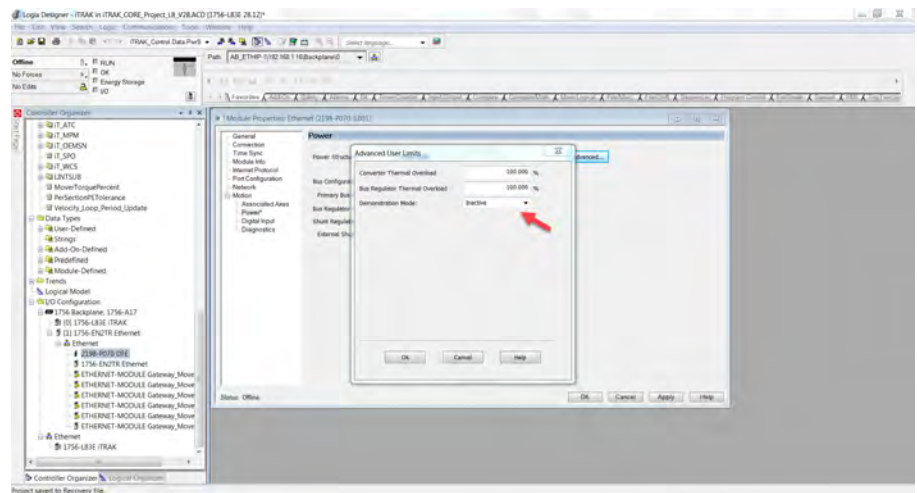
8. In the Advanced User Limits dialog box, verify that Demonstration Mode is set to Inactive.

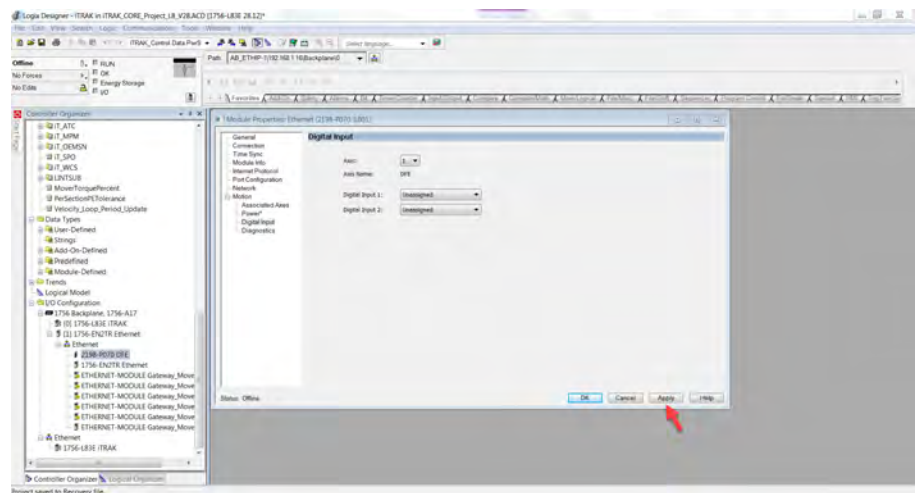
9. On the Digital Input tab, verify that Digital Input 1 and Digital Input 2 are both set to Unassigned, and click Apply.

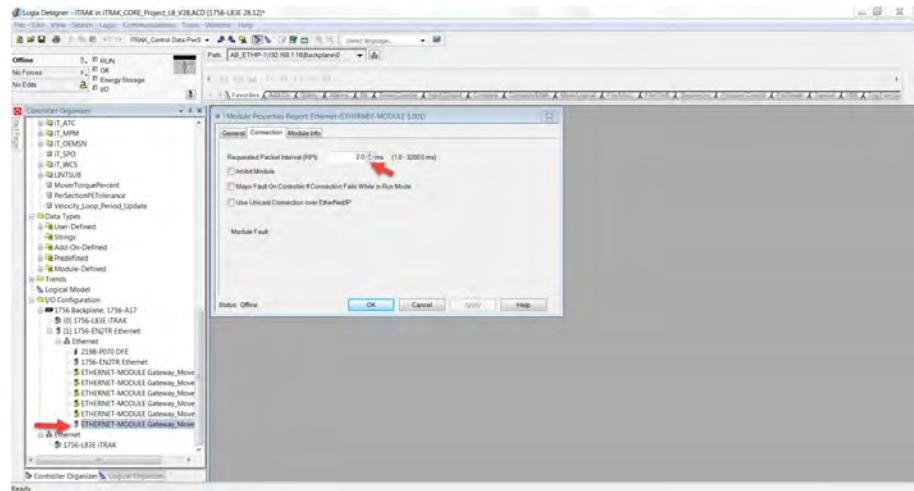
10. Set the Requested Packet Interval (RPI) of the Ethernet modules.

Depending on the number of movers on your system, inhibit those modules not being used. For guidance on what to set the RPI to, see the section entitled [Loop Update Rates on page 31](#).

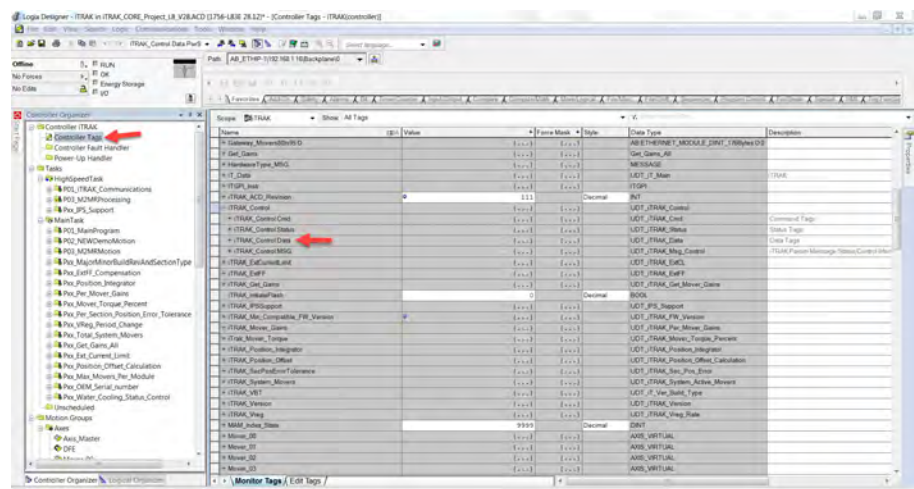
11. In the controller tags, find iTRAK_Control.Data

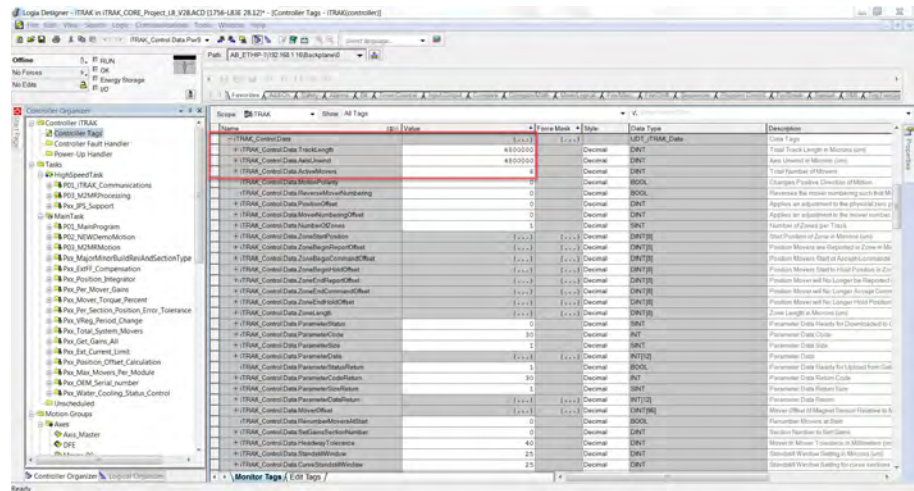
12. Set the track length, axis unwind, and number of active movers.

Track length and axis unwind are the same value and are the length of your iTRAK in μm . For example, a 12 section track is 4800 mm but is set to 4800000 μm in these tags.

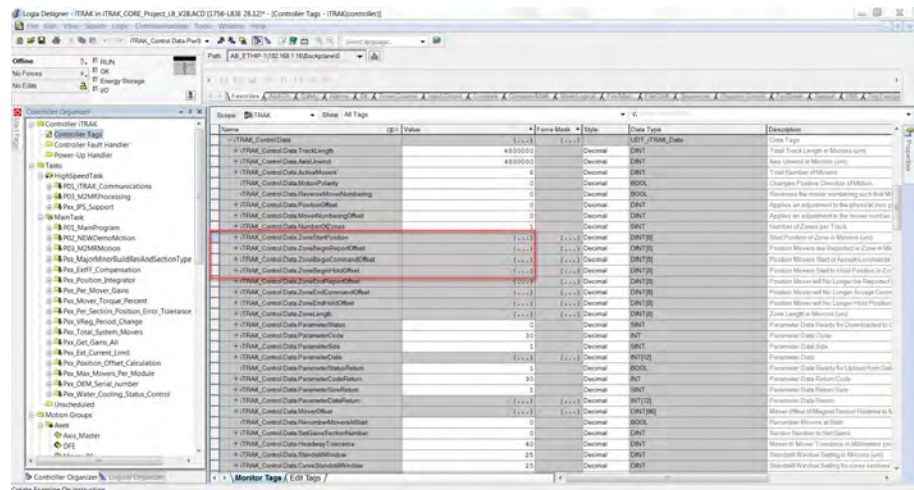
13. Set the number of zones to 1 and enter the value 0 in the [o] array for each of the following tags:

- Zone Start Position [o]
- Zone Begin Report Offset [o]
- Zone Begin Command Offset [o]
- Zone Begin Hold Offset [o]

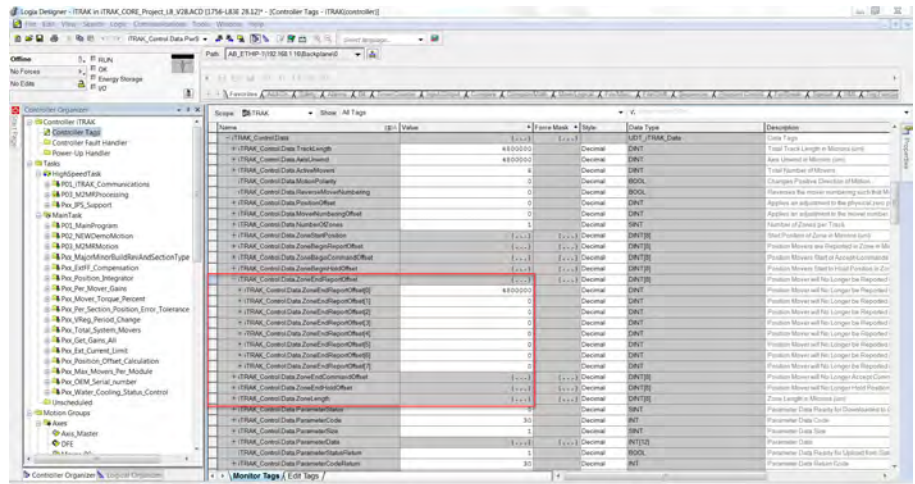
14. Set your track length in μm in the [o] array (for example, 4800000), for the following tags:
 - a. Zone End Report Offset [o]
 - b. Zone End Command Offset [o]
 - c. Zone End Hold Offset [o]
 - d. Zone Length [o]

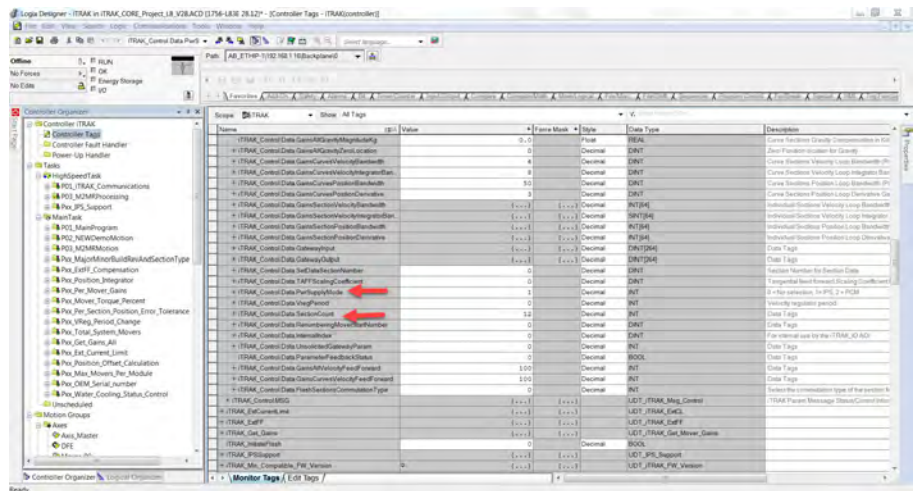
15. Set the Power Supply Mode, type 1 for iPS and 2 for PCM, and then type the correct number of sections on your system.

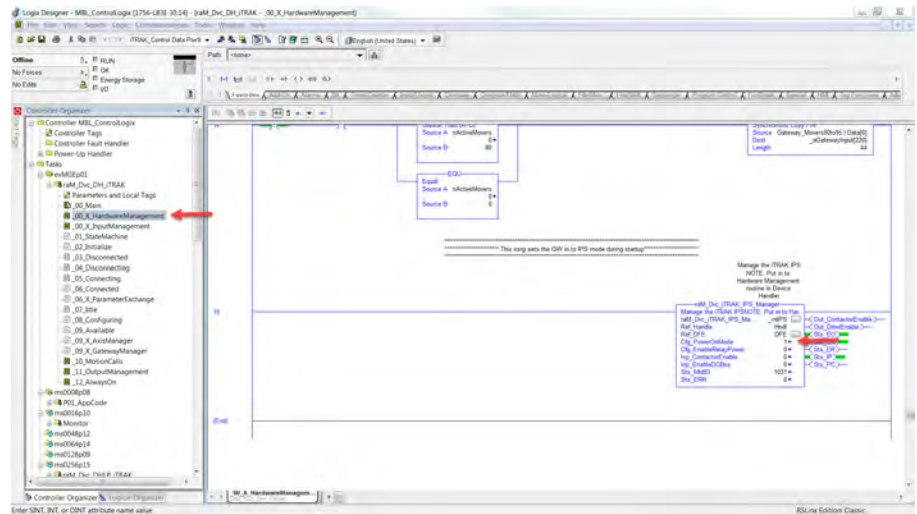
1. Locate the Device Handler (DH) in the Controller Organizer, expand it, and find oo_X_HardwareManagement.

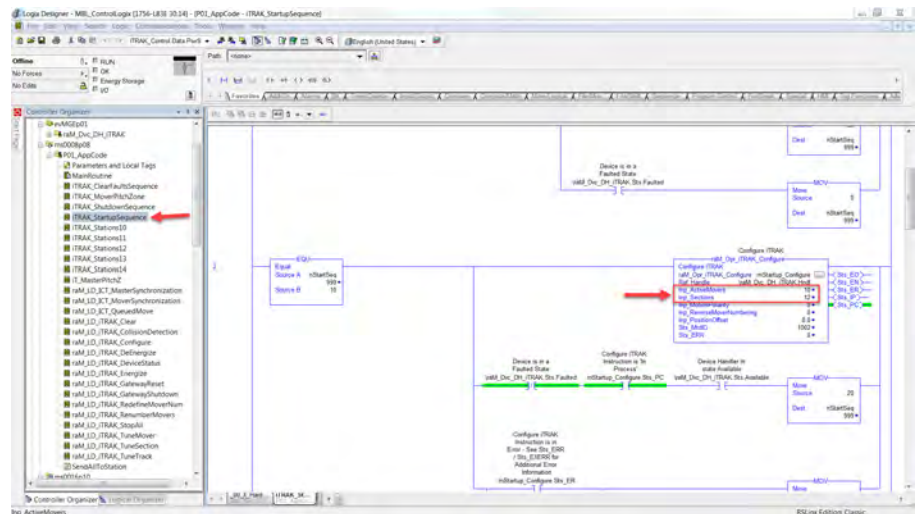
2. In the last rung, make sure you have the appropriate power supply manager, either iPS or PCM.
3. Set Cfg_PowerOnMode to 1.
4. Find the iTRAK_StartupSequence.

5. In rung 2, there is a Configure iTRAK command. Set the number of movers on your system and type the number of motor sections.
6. Download your code to the PLC.

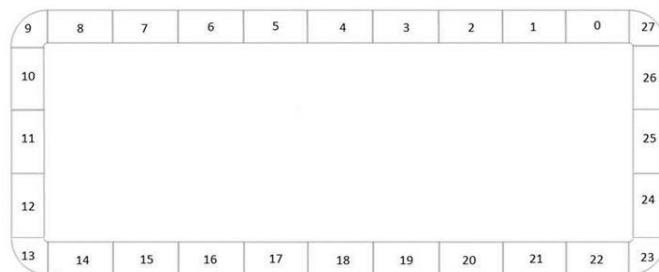
12. Completed an additional set of tests by using a visual of the track to understand the testing.

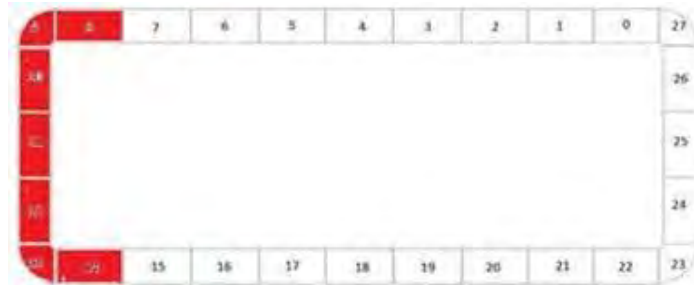
13. Connected Sections 8...14 to the Gen 2 gateway and had 1 mover jog back and forth at 600 mm (23.62 in.)/s.

Observed no improvement in the curves, but straight sections 8 and 14 were markedly smoother.

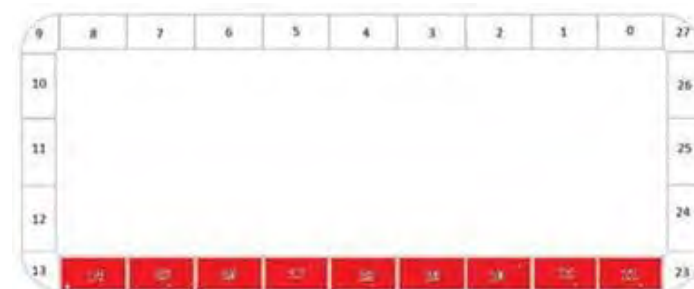
14. Connected straight sections 14...22 to the Gen 2 gateway and had 1 mover jog back and forth at 600 mm (23.62 in.)/s.

Motion was exactly as expected—smooth with no servo oscillations on the mover.

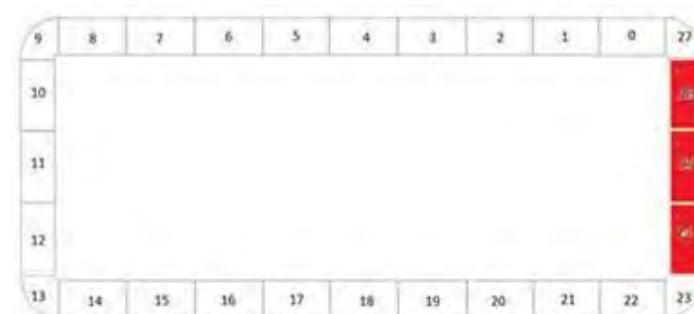
15. Connected straight sections 24...26 to the Gen 2 gateway and had 1 mover jog back and forth at 600 mm (23.62 in.)/s.

Sections 24 and 25 behaved poorly with rough motion with servo oscillation. Section 26 performed as expected

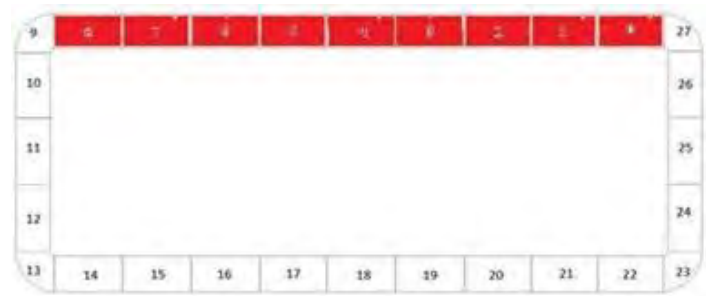
16. Connected straight sections 0...8 to the Gen 2 gateway and had 1 mover jog back and forth at 600 mm (23.62 in.)/s.

Motion was exactly as expected—smooth with no servo oscillations on the mover.

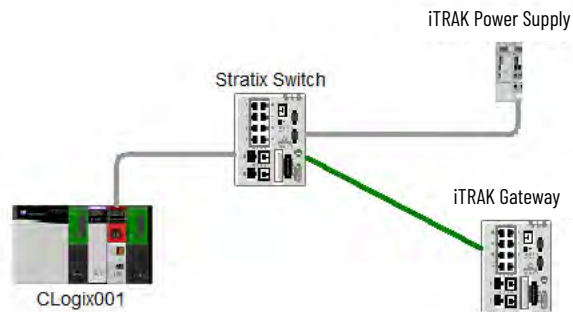
1. After a power cycle, the gateway hangs waiting for a power supply configuration. This is due to the Stratix switch booting up much slower than the PLC and gateway.
2. The gateway requests a power supply configuration once and if it does not receive it generates an error code 28.

- a. The screenshot below shows the customer's original ethernet communication topology.

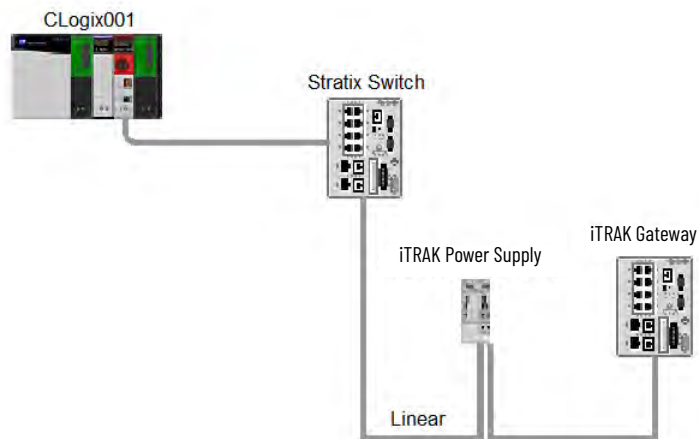
3. The customer's ethernet topology was changed such that the iTRAK Power Supply (iPS) and gateway connect directly to each other after the switch. This allows the gateway to receive its power supply configuration and continue with its boot up.

The solution to error code 28 is to have the proper topology for ethernet communications. The iPS and gateway need to be talking to each other past the switch.
